Implementation of and deployment of a large scale programme – Magnetometers

**Felicity Lockett
Transport for London**

20th September 2013

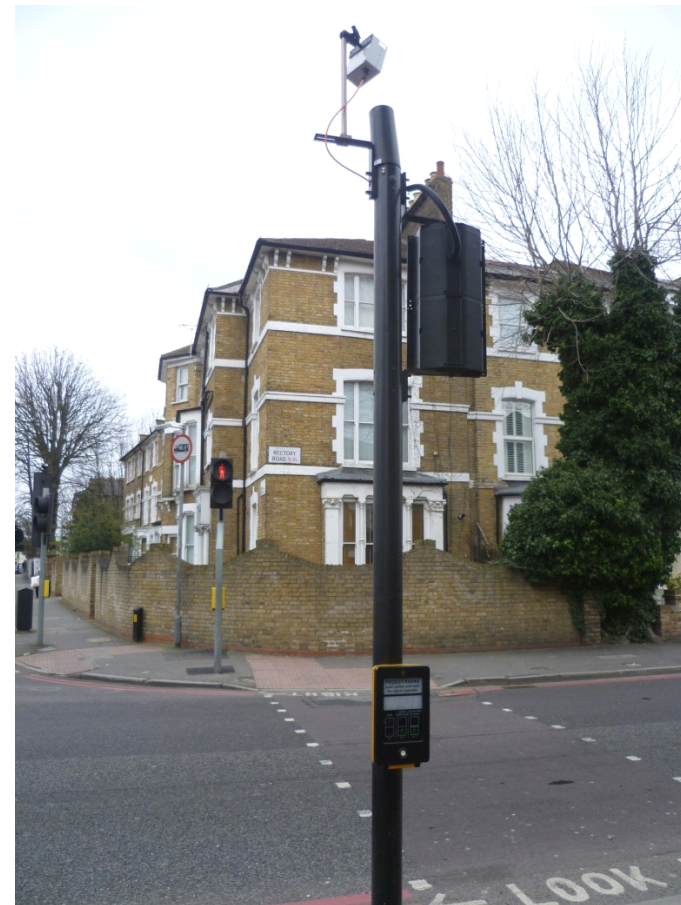
Equipment mounting height

- AP mounted on signal pole ~3.7m above ground
- Repeater mounted 3.5m-4.0m above ground
- 200m range found to be too long in some instances

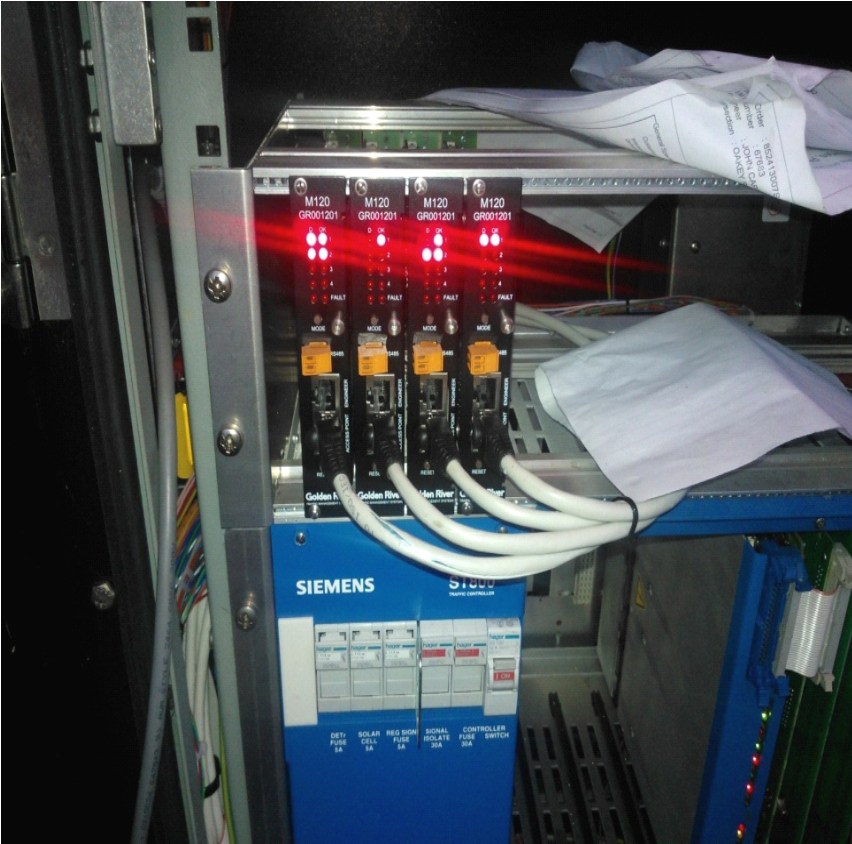
Cable terminations

Cables direct to card

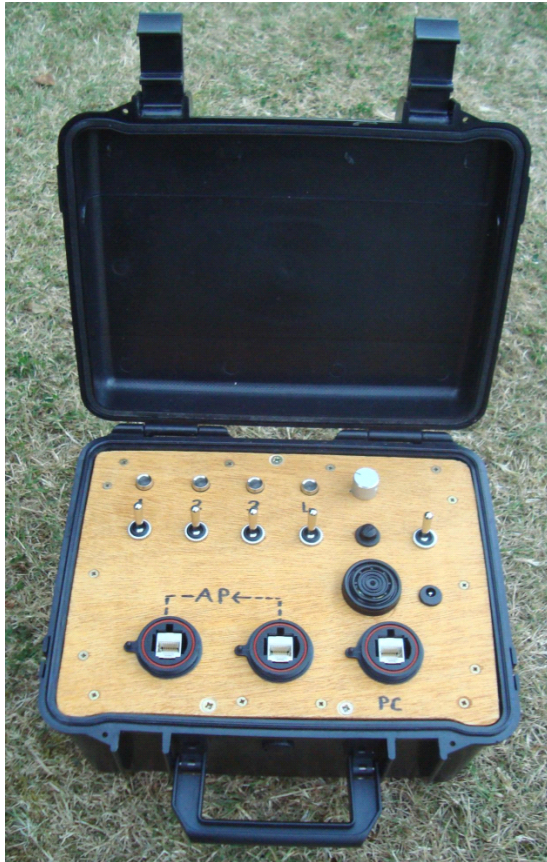
Mobile Access Point

Used for:

- Monitoring of sensor activation
- Changing of remote units RF channels
- Taking signal strength measurements
- Scanning for an unknown sensor
- Proving Access Points and interface cards

- More accurate cost model for future business cases – RSM SCOOT
- Design and installation document
- Revised commissioning procedure to ensure robustness of wireless network
- Fault finding guide to assist maintenance engineers
 - Mobile access point
