A303 Countess Roundabout

Alistair Gollop

September 2011

Innovation and Integration

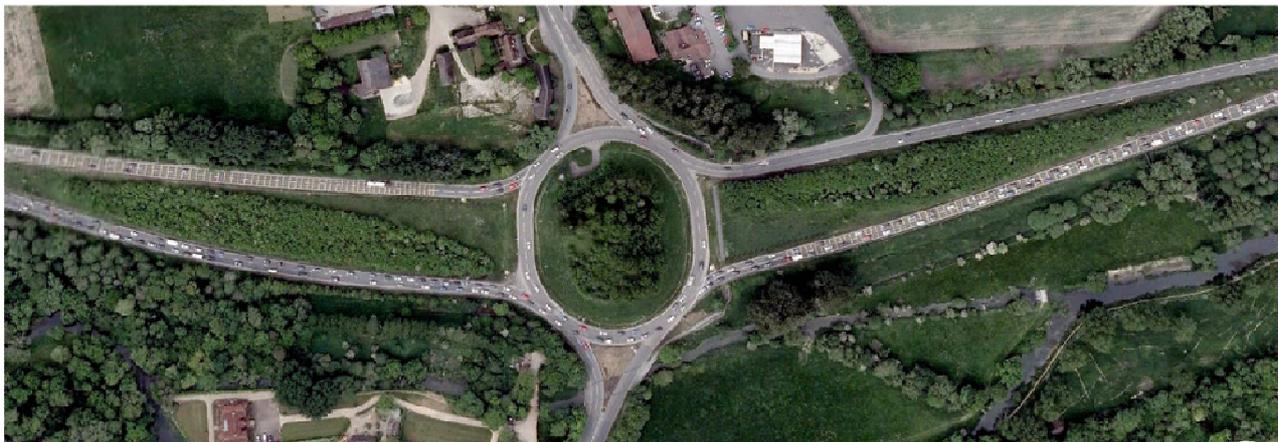
A303 Countess Roundabout – Aerial view before the scheme

The design of the roundabout, which was originally constructed in the 1960's, was implemented to allow for the possibility to grade separate the junction at a later date, possibly during the construction of the envisaged continuation of the dual carriageway section westward. Because of its geometry, the roundabout has an elongated central section which resulted in high circulatory traffic speed. In addition, with little horizontal deflection on the mainline carriageway approaches to the roundabout, coupled with the national speed limit (70mph), resulted in encouraging high entry speeds. [NB: Although a system of street lighting on the last approximately 100 metres of each approach to the roundabout should have theoretically restricted speeds to 30 mph, this was not signed and driver behaviour demonstrated that the majority continued at the same speed through this section.] These issues resulted in difficulties for many drivers on the A303 approaches in gap acceptance because of an inability to accurately determine the speed of traffic on the circulatory carriageway.

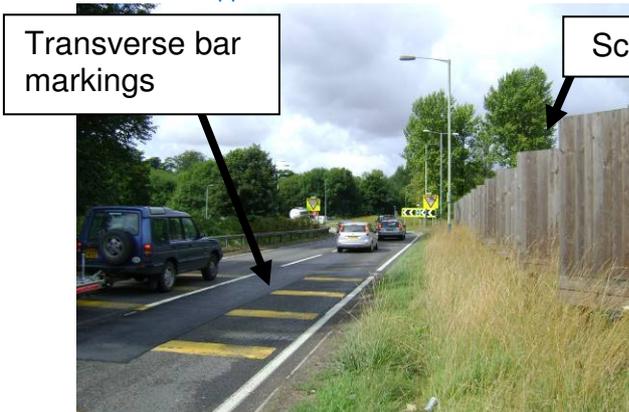
A303 Westbound approach – before scheme

Previous attempts to curtail vehicle entry speeds on the mainline carriageway approaches had included the use of transverse bar markings and screens mounted in the central reservation to limit visibility of the opposing traffic. However, it is clear from the accident data that these were not successfully overcoming the issue.

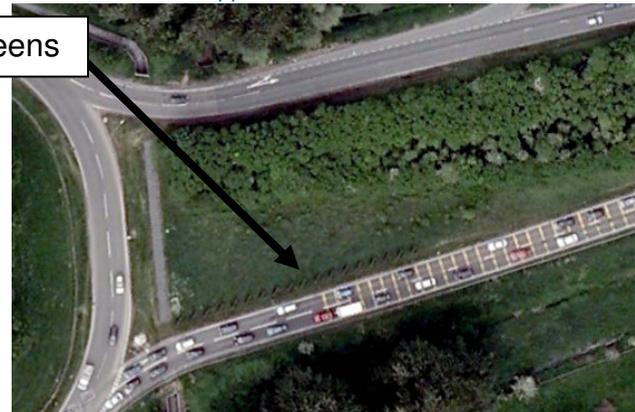
A303 Westbound approach – aerial view before scheme

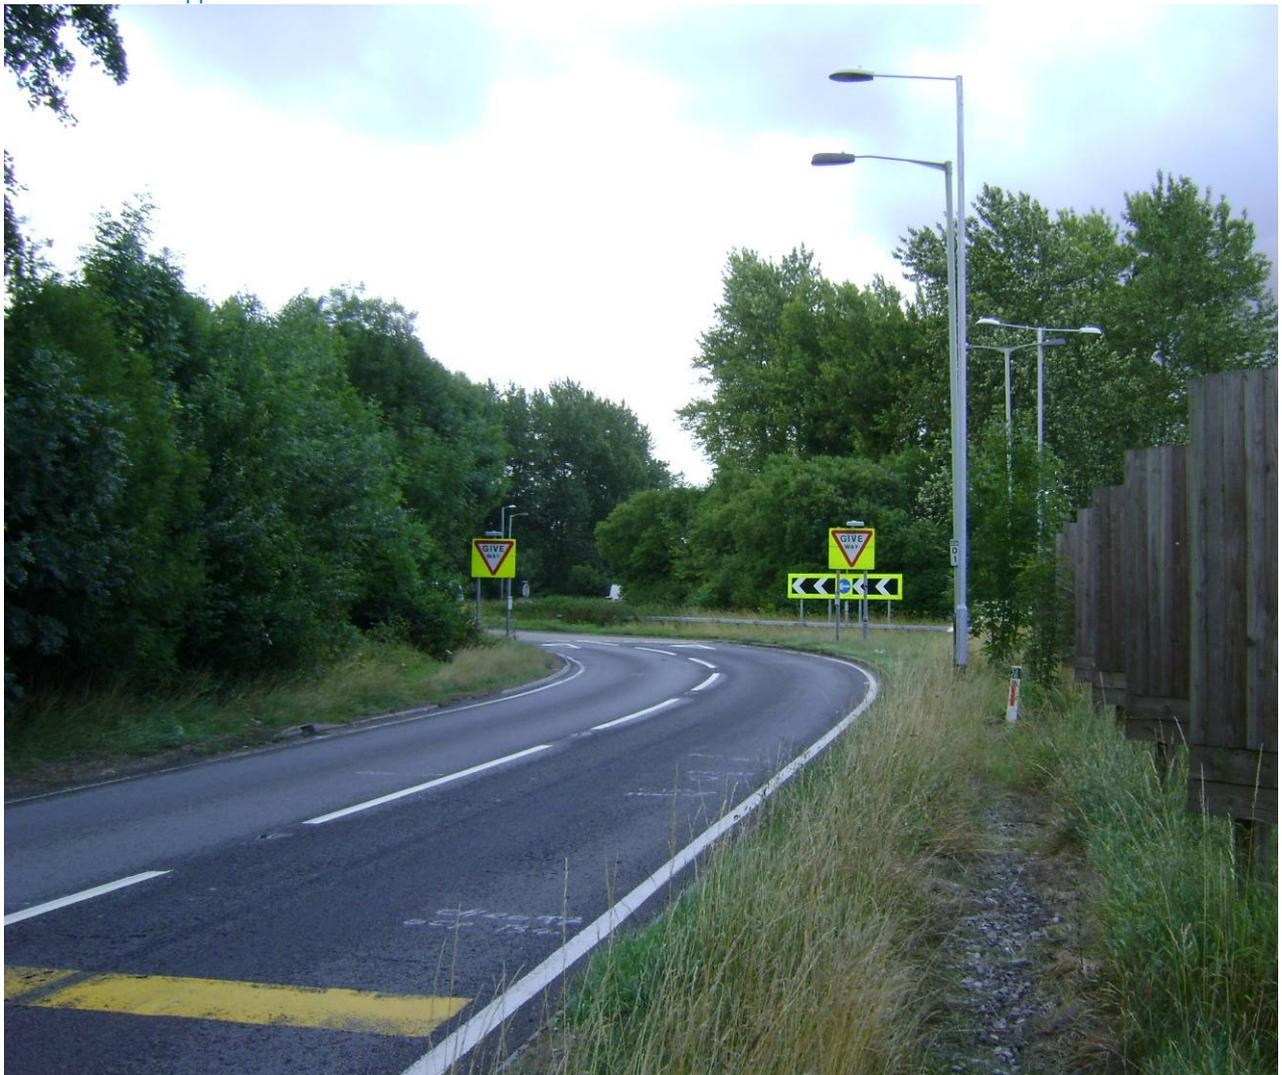
The eastbound approach – view before the scheme

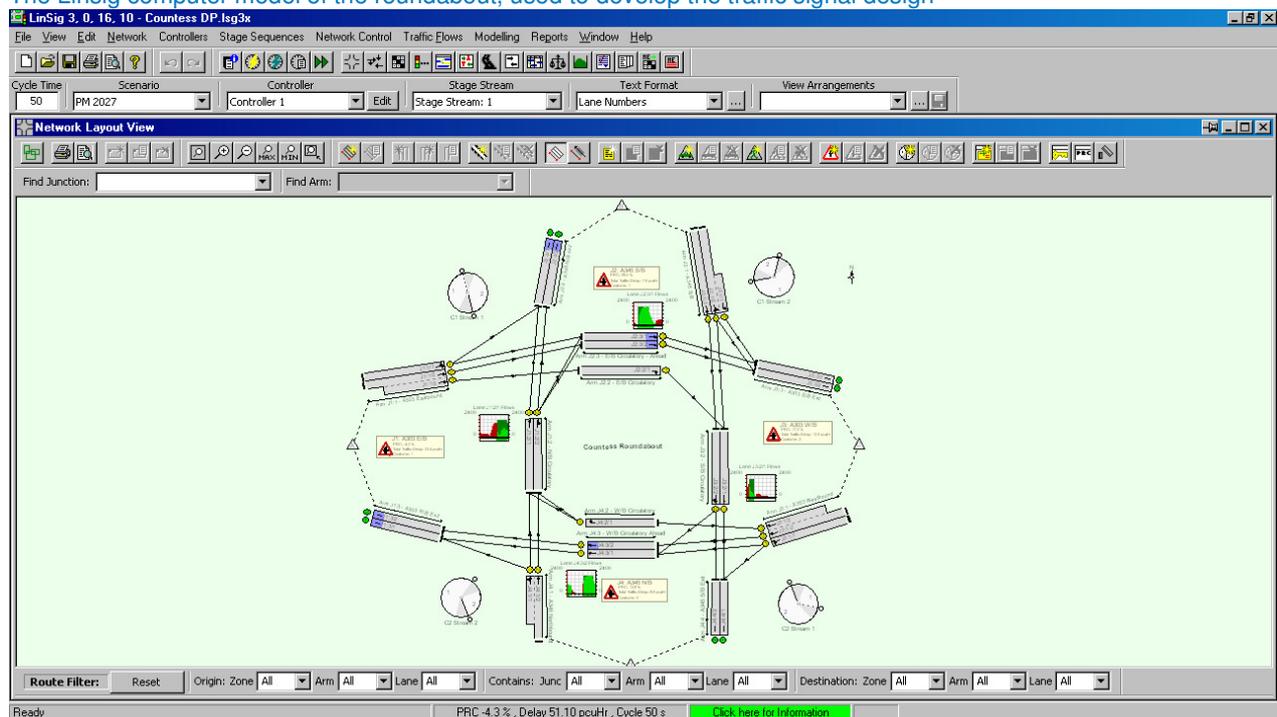
The Linsig computer model of the roundabout, used to develop the traffic signal design

The signal design for the scheme not only had to account for the predicted traffic growth to 2024, but also had to allow for a heavy increase in HGV traffic which could emanate from the proposed development of a number of distribution centres along the A303 corridor. The junction was modelled in Linsig, which confirmed that extra localised capacity would be required to meet the forecast traffic volumes. This revealed that the A303 approaches should be locally widened to three lanes on the approaches to the roundabout, but that the extra capacity on the circulatory carriageway would only be required for the east/west-bound traffic. It was decided therefore, that alterations to the geometric design of the roundabout would be made to tackle not only the capacity issues, but also to optimise the design from a safety

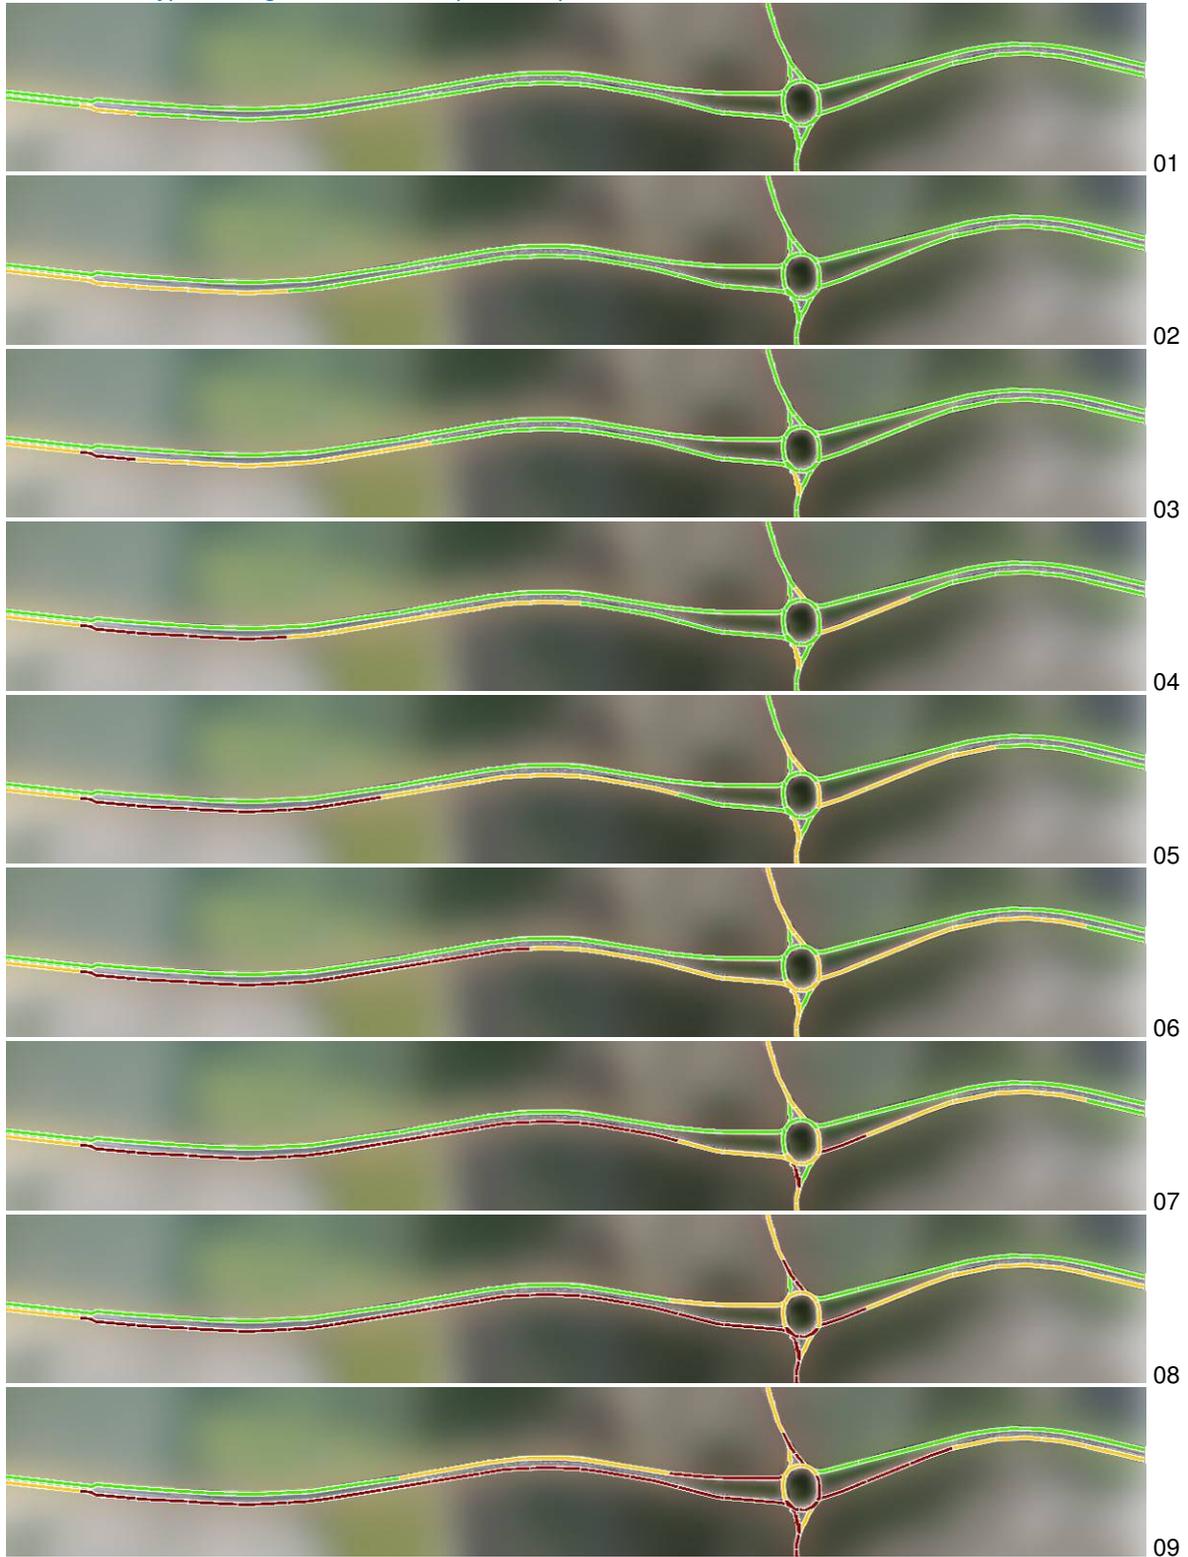
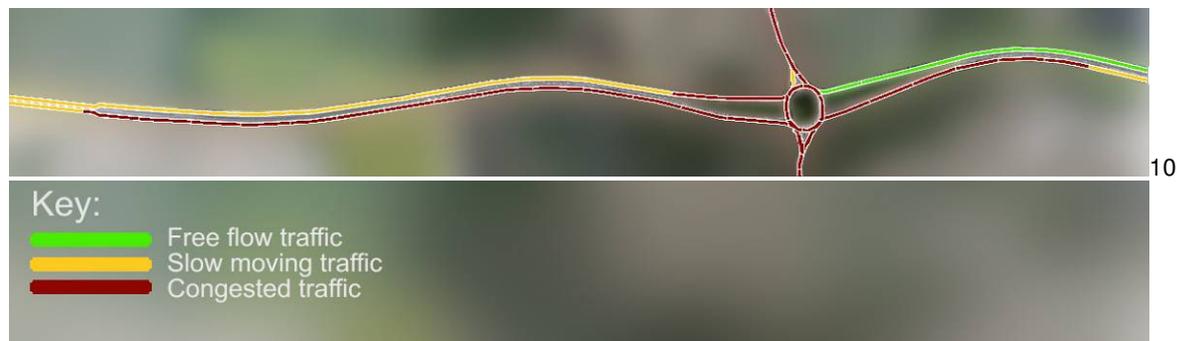
Illustration of typical congestion formation pattern – pre-scheme

In addition, Countess Roundabout also suffers from chronic exit blocking on the westbound carriageway. The dual carriageway ends one mile west of the roundabout, where the reduction in capacity which occurs at the merge-down, at the point where the two westbound lanes reduce to one on the single carriageway section, causes flow breakdown to occur. During normal daily operation, there is adequate vehicle headway to allow the merge-down to cope with demand, however flow breakdown occurs during the course of weekly peaks (typically Friday PM and Saturday) and during exceptional events (typically bank holiday periods). In periods of excessive demand, the queue formed at the merge down would routinely stretch the

mile back to the roundabout, then stretch back to around a mile (during weekly events) or two to three miles (during exceptional events) before the junction. Because there was no control over traffic entering the roundabout, westbound traffic would continue to enter, effectively blocking the local cross traffic movement on the A345 Countess Road, due to the consequential grid-locking of the roundabout. This in-turn would lead to traffic congestion occurring in the surrounding road network, causing severe delays in the centre of Amesbury (located 1 mile south of the junction).

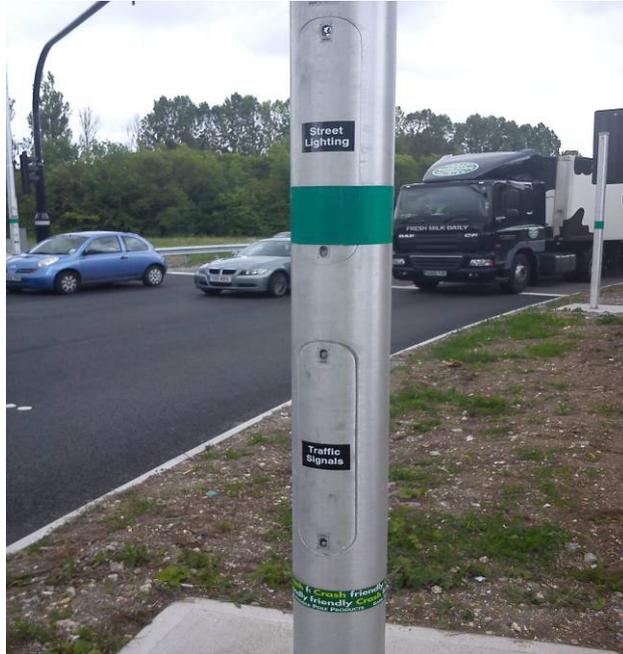
Separate doors on shared columns

It was decided to investigate the possibility to co-locate these facilities. The duct network was designed to use common draw pits, but to use segregated ducts to separate the cabling. The design of a lighting column which could co-locate both street lighting and traffic signals was investigated, and a suitable manufacturer identified. It was decided that the shared columns would be equipped with two door apertures in order to allow the two sets of cable terminations to be separated. The doors are clearly marked externally for “traffic signals” and “street lighting” respectively. Since the columns are passively safe, and are designed to yield in the event of a vehicle strike, both systems would be fitted with electrical isolation systems which are activated by inertia switches. Because of the difference in the electrical potentials (the street lighting uses mains (I.E. 240v LV) compared with the traffic signals which are extra-low voltage (I.E. 48V ELV)), the isolation systems have been kept separate from each other. The traffic signal isolation equipment is housed in miscellaneous equipment cabinets adjacent to each traffic signal controller, whilst the street lighting system uses individual enclosures located in the adjacent draw pit.

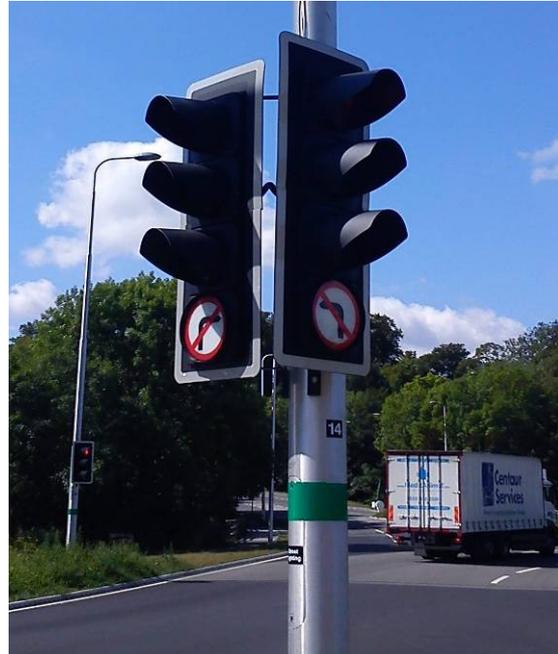
View of two of the shared columns

- **The duct network** – Both specialism’s were using a fully ducted network, which was largely located in similar positions.
- **Column’s** - Six locations were identified where traffic signals would be located in close proximity to lighting columns.

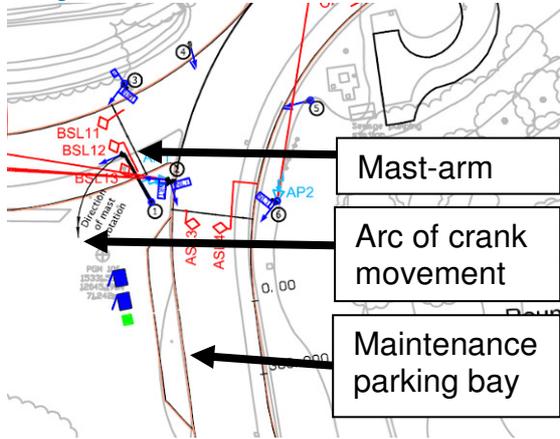
Design of mast-arm in relation to the maintenance bay

In order to maximise forward visibility of the traffic signals on the A303 mainline carriageway approaches, it was decided that supplementary high-level signals would be necessary. This was particularly necessitated because of the lane flare on the final approach, which results in three lanes for the last 100m. Because of the high incidence of HGV's on the route, and the anticipated level of these undertaking right-turn movements at the junction, it was felt that it would be common for other drivers to be affected by the "canyon effect", where the presence of tall vehicles in lanes 1 and 3 could obscure the view of the traffic signals to following drivers. This has been overcome on other schemes by using a 6m pole with a supplementary high level repeater for the off-side duplicate primary, however this can lead to access issues requiring road-space for maintenance, and does not totally solve the visibility issues. It was therefore decided to look at a new mast-arm design, which offers the normal benefits of placing the additional signal head over the centre of the carriageway, whilst also overcoming the normal access issues for maintenance. The new style of mast-arm is equipped with a rotating outreach, which allows the arm to be cranked round over the verge when work is needed. The scheme design was therefore undertaken to include a maintenance parking bay on the central reserve, on the near-side of the circulatory carriageway. Because of the geometry of the existing roundabout, the central reserve of the A303 at the roundabout is more than big enough to accommodate this. By implementing this feature, it allowed the design to cater for parking a mobile elevated work platform (MEWP or "cherry picker") in the maintenance bay, and by cranking the arm round, to access it for maintenance without the need to deploy traffic management. The mast-arms are equipped with electrical isolators, which allows the signal head on it to be extinguished, prior to maintenance activities being carried out.

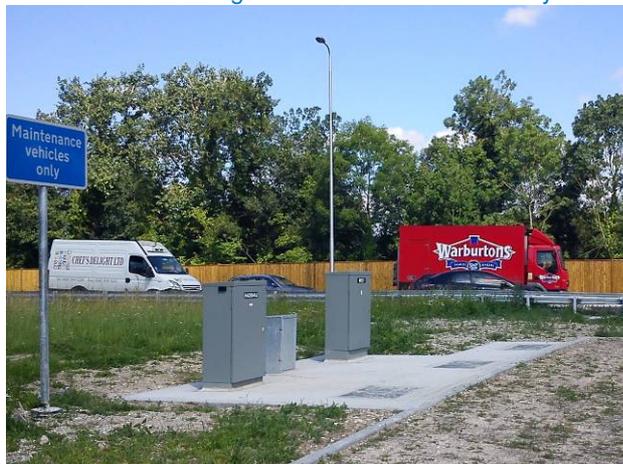
Cabinet hard-standing next to the maintenance bay

The location of the maintenance parking bays also gave the opportunity to position the equipment cabinets adjacent to them, so that they would be easily accessible for engineering staff.

The concrete surrounds to the cabinets, poles and draw pits were found to be highly successful. The design had incorporated a brushed surface texture which was found to offer an effective non-slip surface when wet. The slabs around the cabinets provide a clear working area, which was exceedingly useful during the equipment installation and the commissioning and validation process. The draw pit surrounds also mean that engineers have a good footing when lifting lids, and that there is somewhere to kneel on when working in them. The pole surrounds provide a good quality foundation for the retention sockets, which is particularly important in the event of a vehicle striking a pole. One possible development with the design of these for subsequent schemes, may be to elongate one side of the pole slab, to allow maintenance engineers' 'A-frames' to be sited on a secure level surface.

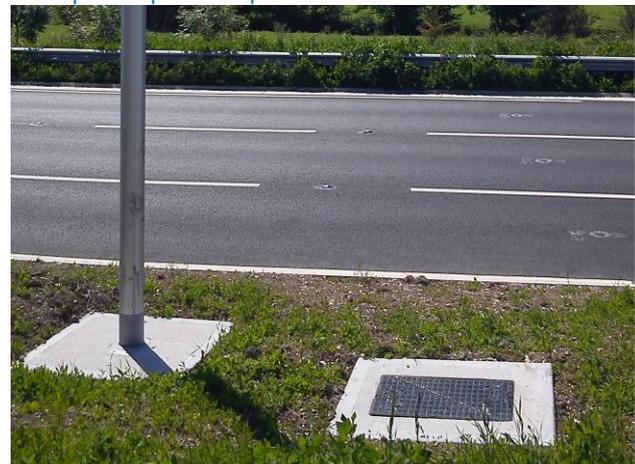
Examples of pole and pit surrounds

Previous experience of the occasional poor civil's installation of retention sockets led to the development of a design to include a concrete surround in soft-verges, so that the extent of the surrounding concrete foundation is brought up to surface level. This adds the advantage of ensuring the integrity of the foundation, whilst at the same time offering a clear working area, clear of vegetation. It was decided that the use of a concrete pad around the area of the controller cabinets, electrical feeder pillar, draw pits and the earth point, it was felt that it would make the finished installation tidier and easier to work at in the future. The draw-pits located in front of each cabinet are set back a metre to allow engineers to work at the cabinet if the pit lids are open. The use of this type of concrete pad was also specified for the remaining isolated ducting system draw pits, to allow the lids to be lifted easily.

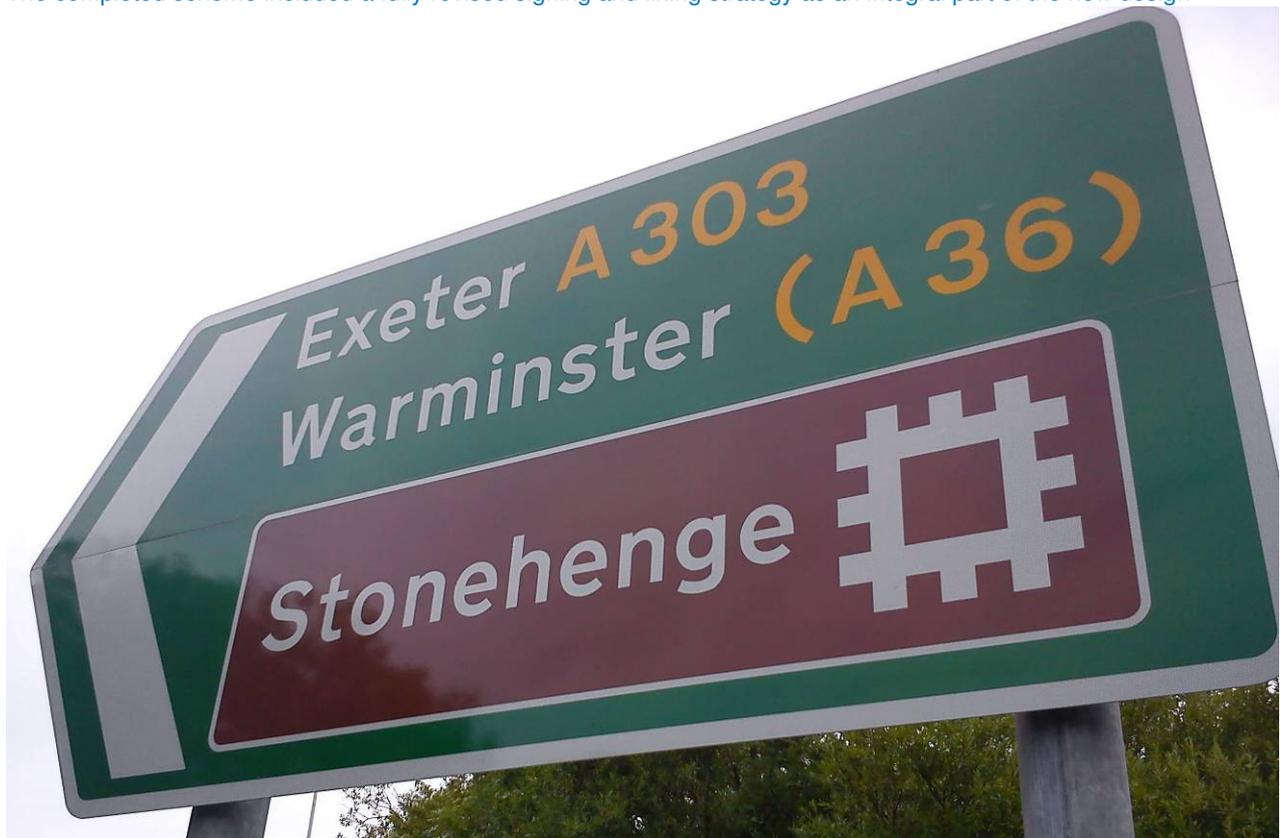
The completed scheme included a fully revised signing and lining strategy as an integral part of the new design

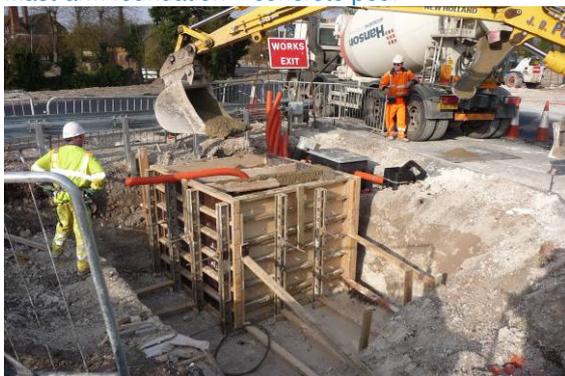
Mast-arm foundation – concrete pour

The foundations for the two mast-arms are 2m square by 1.8m deep, ferrous reinforced concrete, with a mounting cradle, cast in-situ. These were constructed and allowed to cure before the rest of the installation was carried out. Each mast-arm was erected in two parts, with the column lifted into place by a *Hiab* on the delivery lorry. The column was bolted down to the mounting cradle in the foundation, after which the outreach was lifted and fixed into place on top of it. The traffic signal head had been pre-mounted onto the outreach whilst it was still on the ground, and the cable fed through the arm and column before the assembly was completed. After all the fixings had been checked, the rotating mechanism was tested. The installation process for the mast-arms was exceedingly straightforward, and both were erected in a single morning. Because of the way that the system allows the outreach to rotate, it offers the additional benefit of not requiring road-space on the mainline approaches during the erection process.

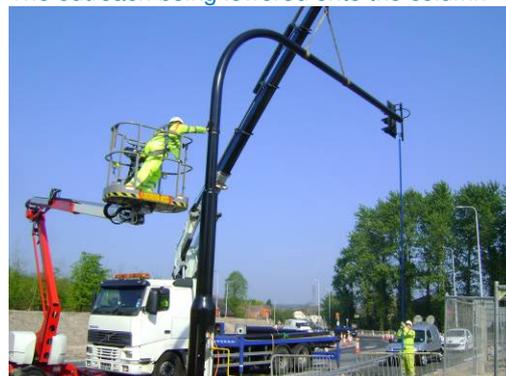
The outreach being lowered onto the column

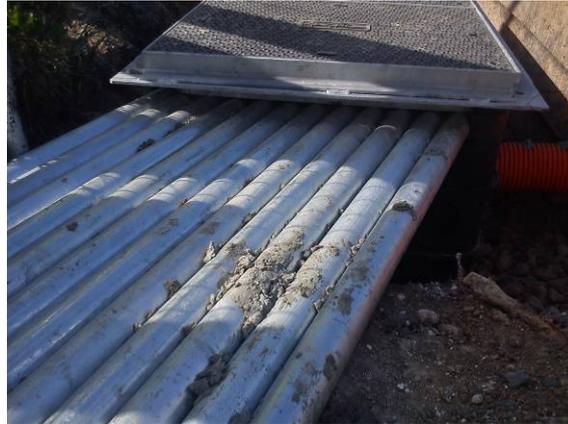
50mm diameter steel ducts, before concrete pour

During the construction of the scheme, an issue was identified with the routing of a number of ducts across the top of the pedestrian underpass. Although the initial trial holes had indicated that there would be sufficient cover in the soft verge over the top of the roof slab, it was found that additional works to the

structure meant that it would not be possible to run 100mm ducts in the affected location. To overcome this, 50mm diameter galvanised steel ducts were used, and by increasing the number, it was possible to meet the capacity requirement for this section of the duct network. The steel ducts were then encased in a poured concrete slab, to protect them from damage.

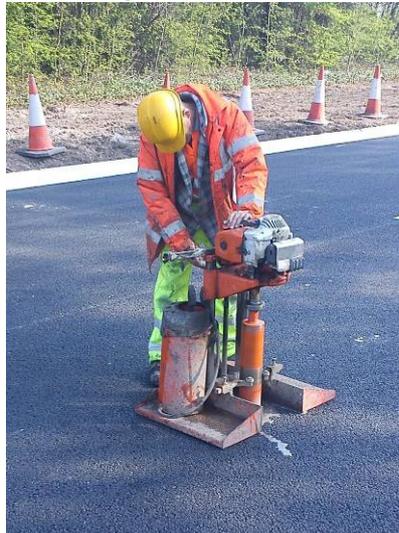
Core drilling

Because this was the first scheme that the signal designer had specified the use of this type of detection (although subsequently designed projects had reached construction before this scheme), a close liaison with the manufacturer was kept, in an attempt to minimise any potential issues. The installation of the magnetometers themselves was exceedingly straightforward; each unit was fitted in a matter of a few minutes. The installers used a large core drill, powered by a petrol engine, to accurately cut the hole into which the detectors were fitted. These were then sealed into place using a two part epoxy resin.

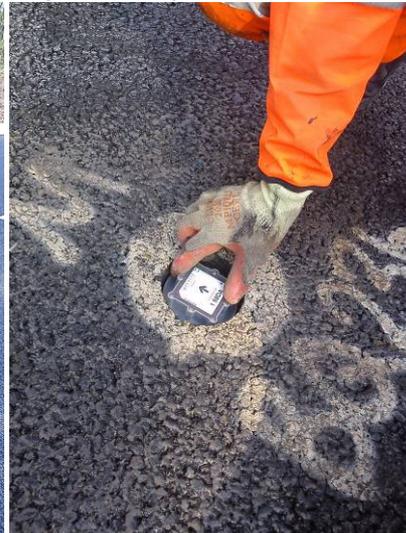
Magnetometer placed in hole

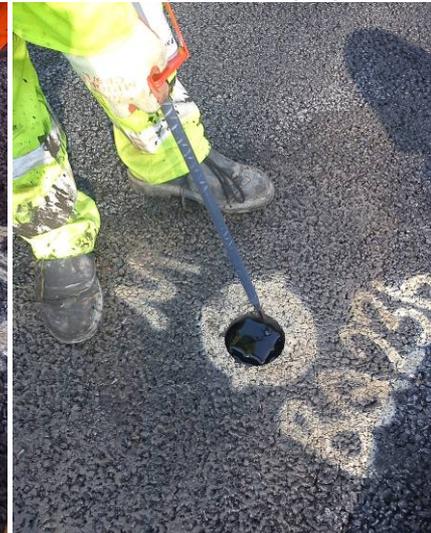
Unit sealed in place with epoxy resin

Although these units were installed whilst the sections of road were closed, it proved that they can be fitted in a much quicker time than a traditional inductive loop, and that because they are positioned in the centre

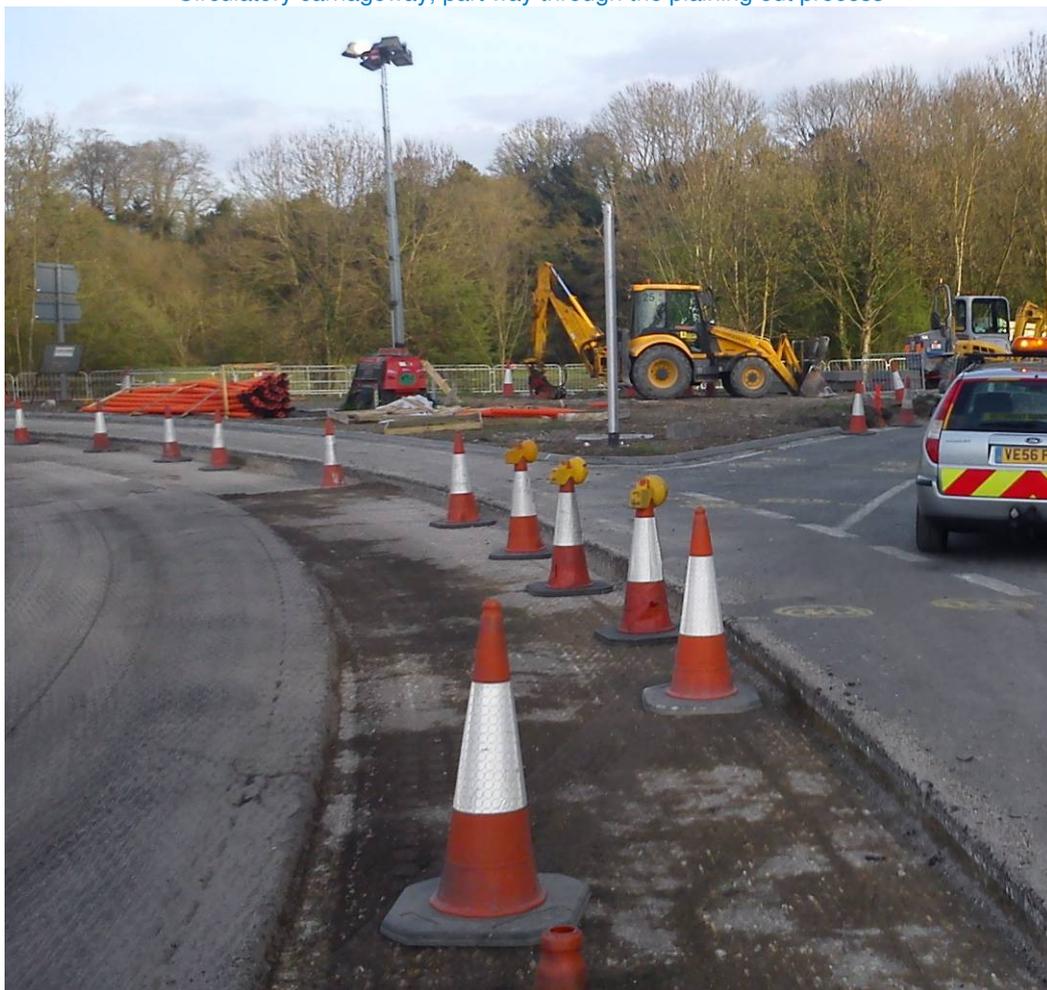
Circulatory carriageway, part way through the plaining out process

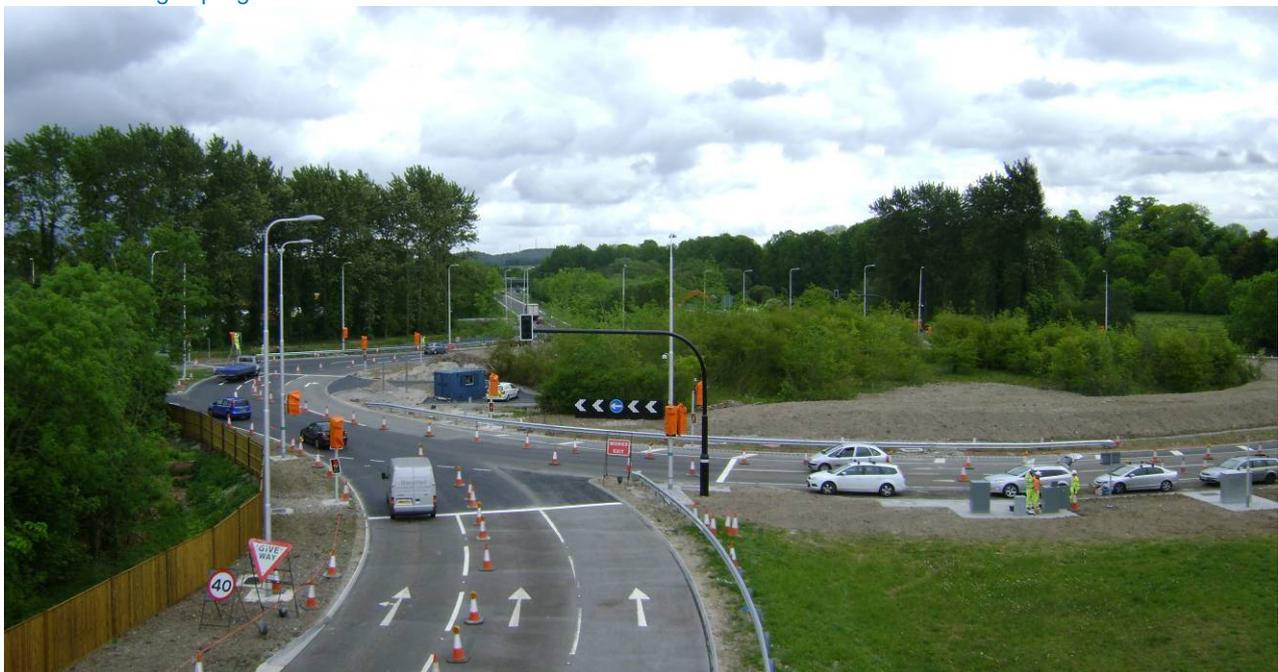
Commissioning in progress

The traffic signal installation underwent a thorough commissioning, where each sub-system was individually pre-tested before the whole installation was system tested. Once operational, a validation process was undertaken immediately, in order to optimise the operation of MOVA and the congestion management plan.

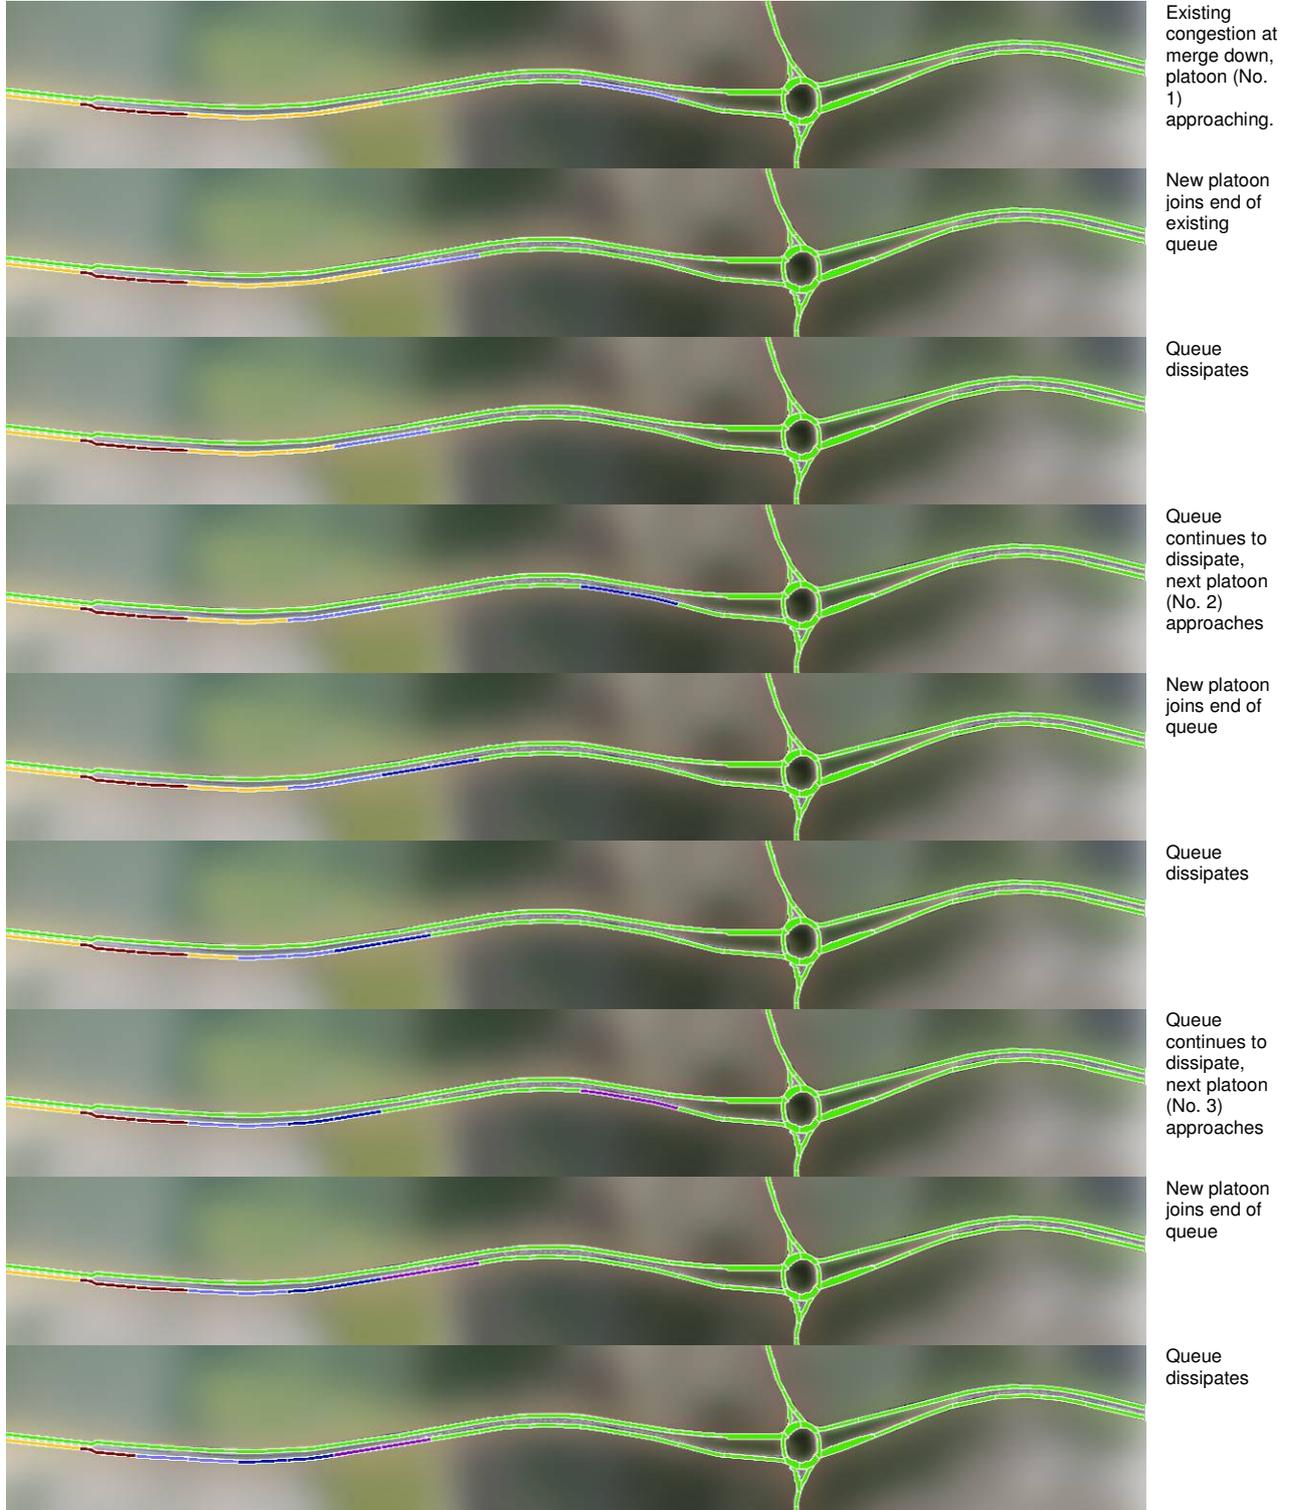
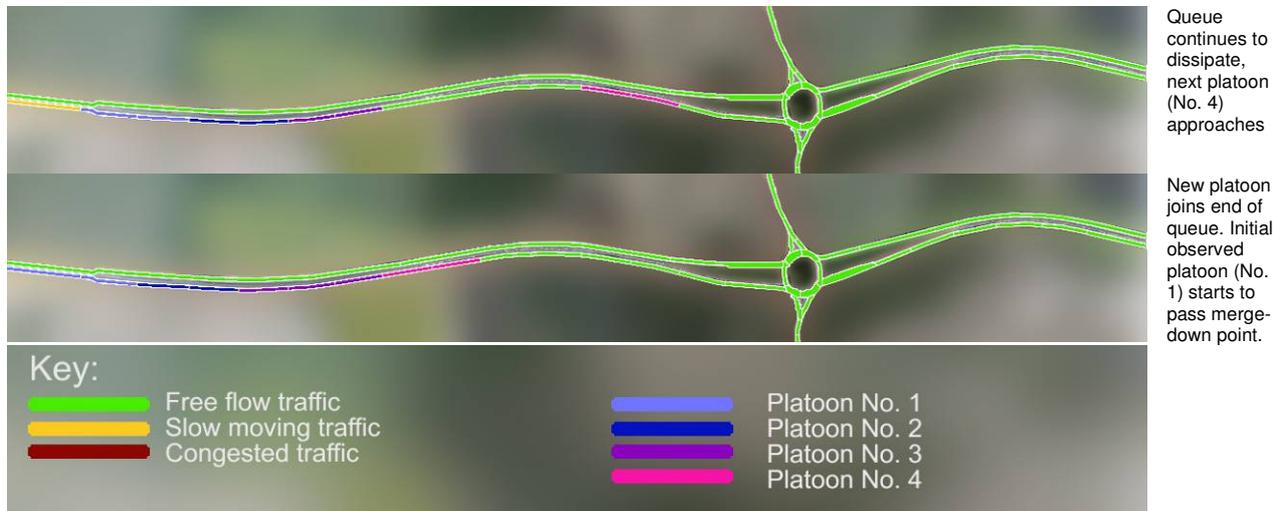
Simplified illustration of platoon progression through congestion

However, under heavier volumes of traffic, an interesting effect was observed on the westbound traffic downstream of the roundabout. Before the roundabout was signalised, once the traffic exceeded a threshold, a queue would form at the merge down point at the end of the dual carriageway. Because of the dispersed but constant nature of the traffic arriving at this bottleneck, the queue length would build following the characteristics of the shockwave effect, and could propagate in length to stretch back over the mile distance to the upstream roundabout, in as little as 5 minutes.

After the signals were operational (under similar traffic flow conditions), although the queue would still form at the bottleneck, the effect of the traffic being split up into compressed platoons by the traffic signals, would result in the queue length oscillating. As a platoon reached the back of the queue, the overall length would grow, but between arrivals would dissipate. Site observations over the course of a number of visits found that the resulting queue length was constrained in all but exceptional traffic conditions. The diagrammatic representation above illustrates the queue length oscillation and the progression of individual traffic platoons through the congestion. In addition, previously the queue would be maintained after its establishment, by even a modest volume of traffic, and would only disappear when the incoming traffic reduced to almost nothing. With the signals operating however, the queue has been observed to completely dissipate on occasions.

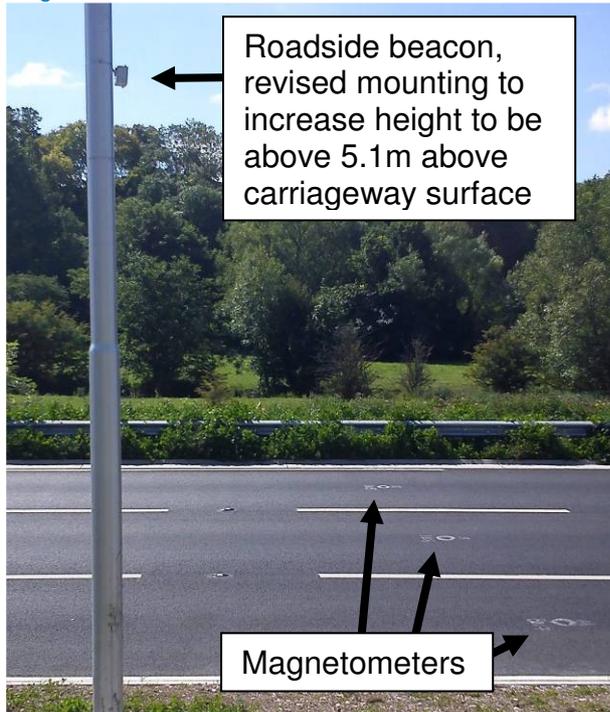
Magnetometers and associated beacon

The issue was overcome by remounting the roadside beacons higher off the ground, so that they were a minimum of 5.1m above the carriageway surface. This ensured that they are above the top of passing tall vehicles, resulting in a reliable signal being maintained between the different parts of the system. This was easily achieved in most locations, because most of the units were banded to street lighting columns. However, for the queue detector positions on the A303 approaches, these had been mounted on the advance destination sign poles, which were not tall enough to achieve the 5.1m height requirement. This was overcome by mounting a “ghost” pole on the rear of the sign plate, and fitting the beacons to these. The operation of this part of the detection system is now indistinguishable from the inductive loops.

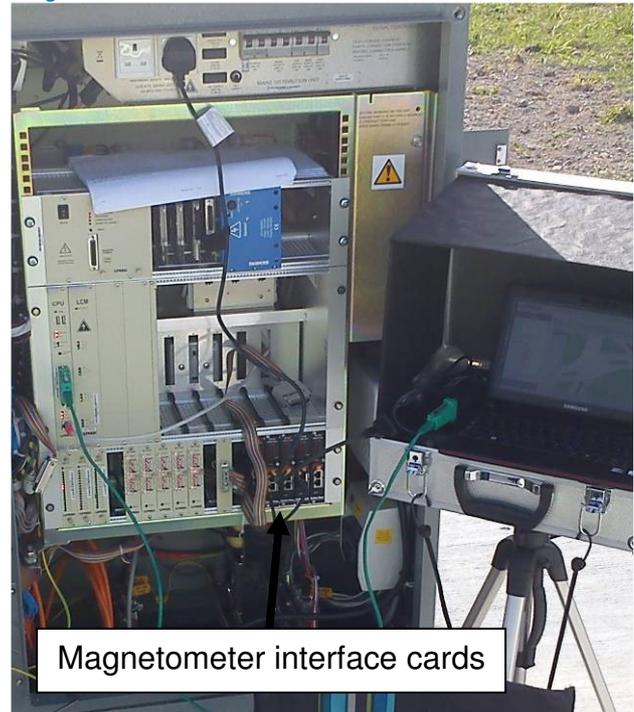
Magnetometer interface cards are located in detector rack

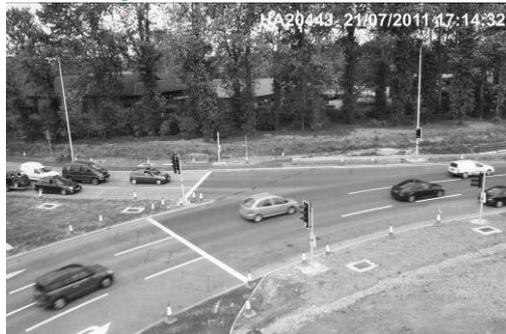
CCTV Image

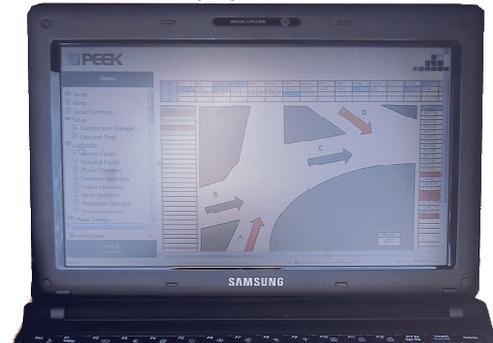
Controller mimic display

monitored in real-time, including a mimic display of the controller operation displaying phase, UTC and input/output information. It also opens the possibility to run two communications channels to the controller equipment at the same time, by using a web-based page via a Wifi link, along with a traditional terminal emulator directly via the engineer's handset port.
