## Jacksons Edge Road: Shuttle Innovations

Jacksons Edge Road in Disley, Cheshire East is a quiet, picturesque small village.

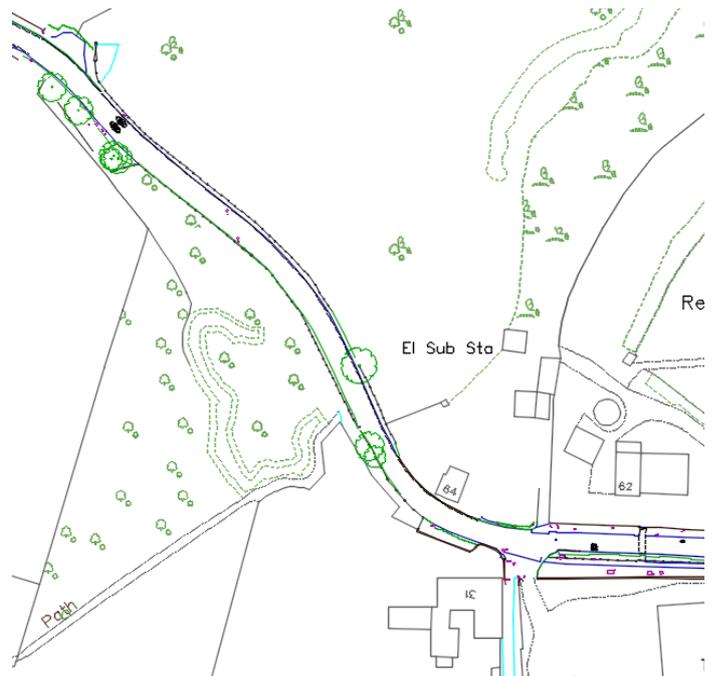
Figure 1 General site layout

Cheshire East Council, through its Cheshire East Highways partnership with Ringway Jacobs identified a need to implement a new footway along this section of road to improve pedestrian access. In turn, this would make the carriageway width narrower, preventing two way traffic passing each other. Consequently, a need for shuttle working traffic signals to control this section of road was identified. Ringway Jacobs turned to Dyyniq to design and implement the signals installation. The site presented a number of specific difficulties in the signal design:

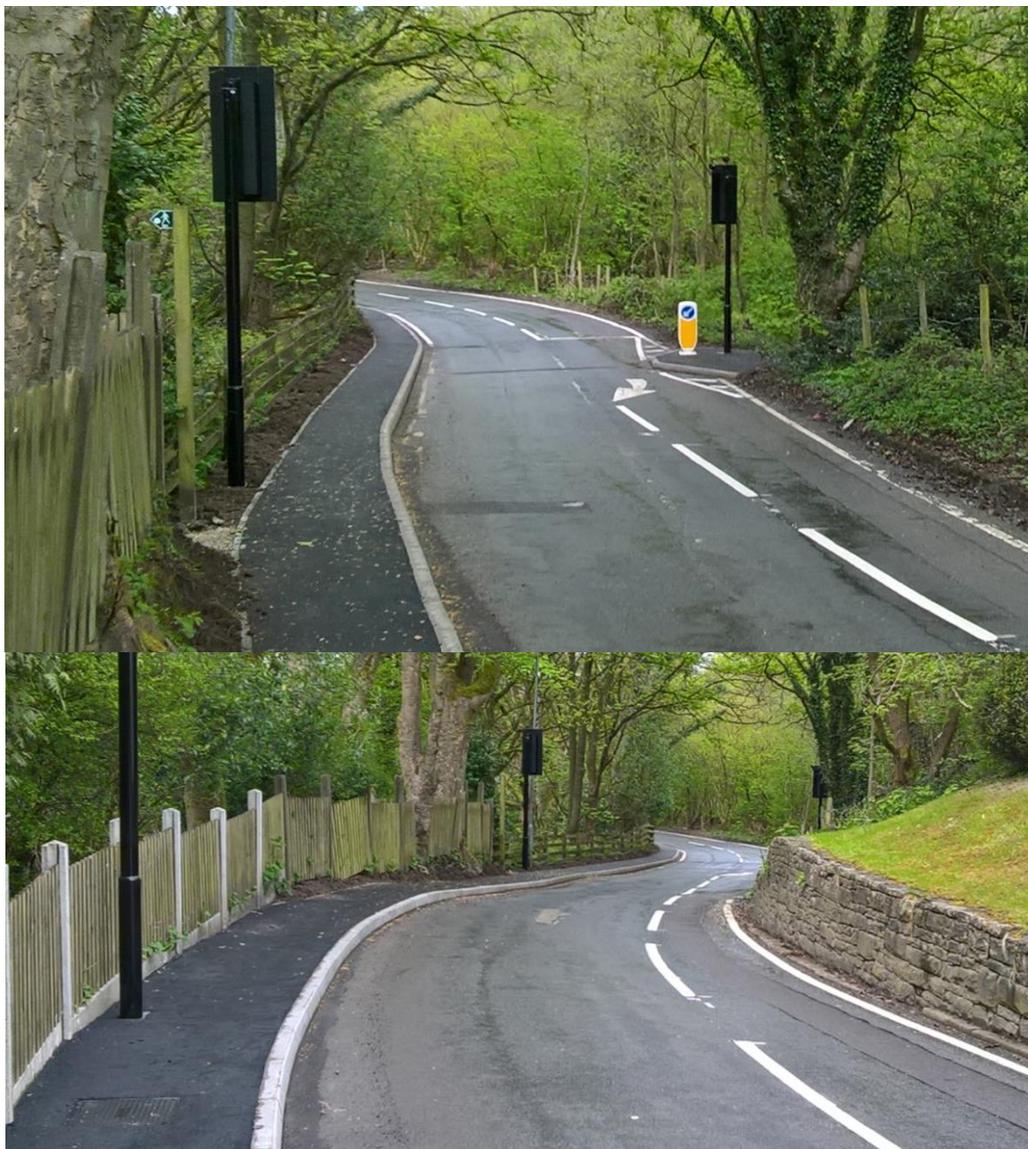
*Figure 4 Uphill white lining*

To further protect very slow cyclists, the design team at Cheshire East Highways used white lining to encourage all drivers to keep to one side of the road, leaving a clear area that could be used by uphill cyclists, removing them from likely conflict with on-coming vehicles should the all-red maximum clearance time be exceeded.

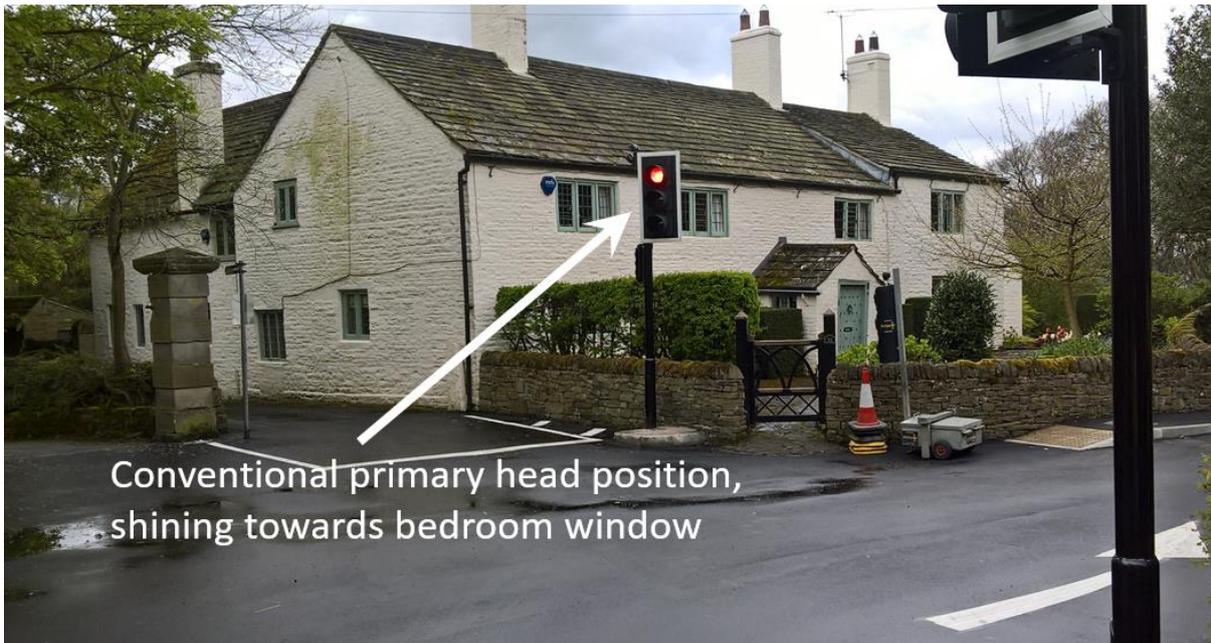
*Figure 6 Private access primary head position*

However, the decision to signalise the one private access presented one particular challenge: The position and height of a conventional primary signal head, which would normally be on red, would shine almost directly into the adjacent cottage window.

Conventional primary head position,  
shining towards bedroom window

Whilst the use of tunnel hoods or similar would probably have solved the light pollution problem, they would have made the signals appear larger and more out-of-keeping with the area.

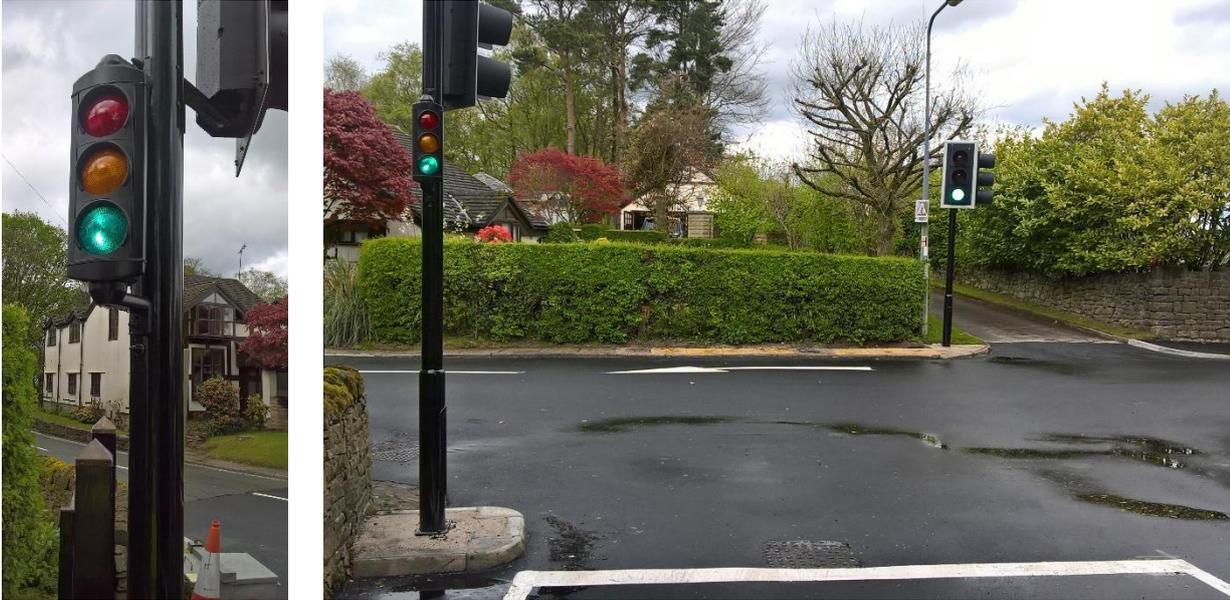
Figure 7 Low level, private access primary signal head

So there was a desire to solve the light pollution and for the signals to become smaller in size. The solution was the use of a modified low level cycle signal head, using a full roundel instead of a cycle aspect. Whilst not a prescribed sign in the TSRGD, in agreement with the highway authority, as the use of this small head was signalling a private access, was backed up with a conventional secondary head and solved a specifically identified problem, it was thought the most appropriate solution.
