Area 4 Validation and Optimisation Programme

Introduction

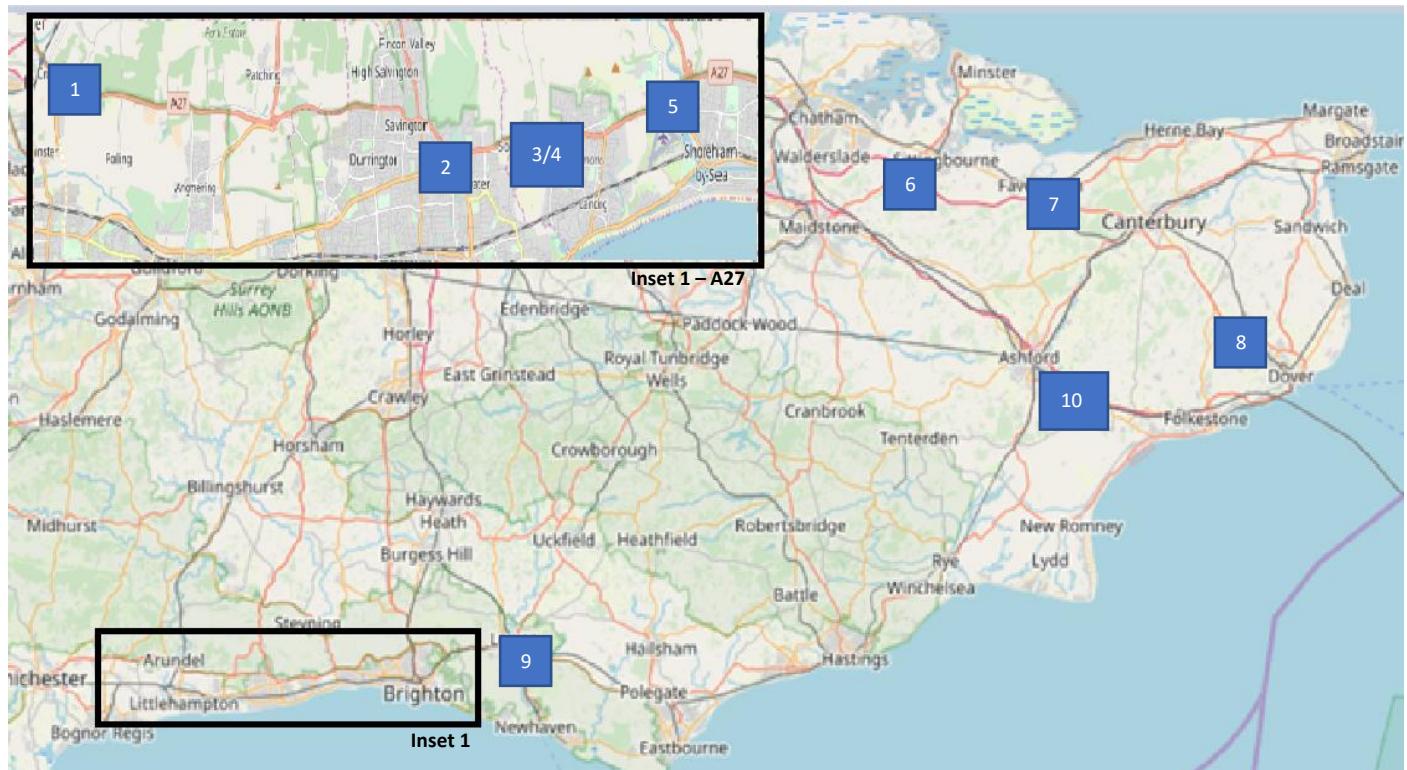
Figure 2 - Area 4 Top Ten Sites (@OpenStreetMaps Contributors)

The location of the sites which formed the 2018/19 programme are shown in **Figure 2**. With reference to **Figure 2** the sites and their primary method of control are shown in Table 1.

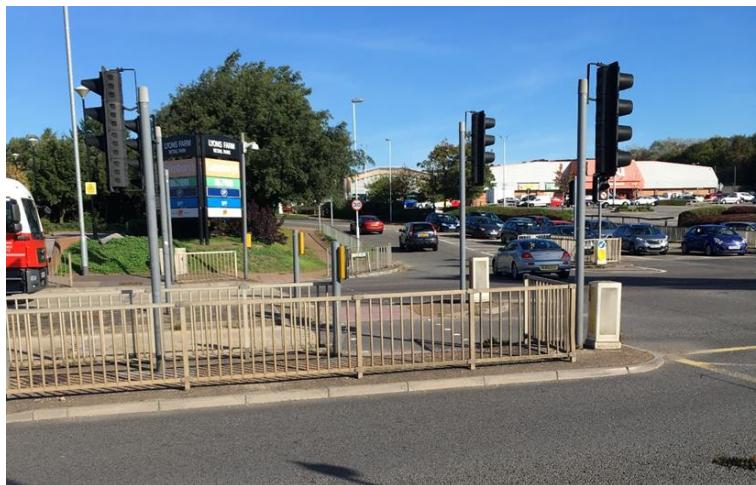
Figure 3 - A27/Lyons Way

The A27/Sompting Road is a 4 arm crossroads which also provides access and egress to the Lyons Farm retail park. The A27/Lyons Way site, **Figure 3**, is also a 4 arm crossroads directly adjacent to the A27 Sompting Road junction. Both sites are controlled together in a single SCOOT region, with CLF fallback should SCOOT control fail.

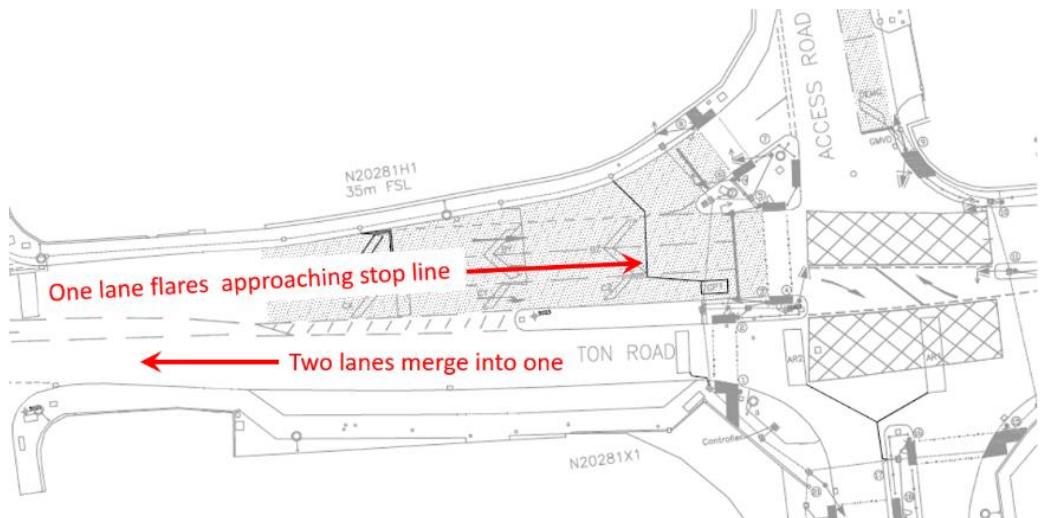
Figure 4 – A27/Sompting Road western edge merges

During the peak periods significant queues form on both the eastbound and westbound A27 approaches. The queues result in significant exit blocking due to a combination of the volume of traffic and the western side of the A27/Sompting junction merging from two lanes into one. On the eastbound approach of the A27/Sompting Road junction approximately 70m before the signals, a single approach lane quickly flares to 2 ahead, 1 right

and 1 left turn lane. Once green time has extended beyond approximately 20-30s performance on this approach is ‘throttled’ by the single lane. Effectively, once green times are above 20-30s, this approach acts as only a single lane and this limits capacity. This leads to significant eastbound queues forming. **Figure 4** refers. There is little that could be done within SCOOT, without implementing upstream ‘gating’ to mitigate the impact of this exit blocking.

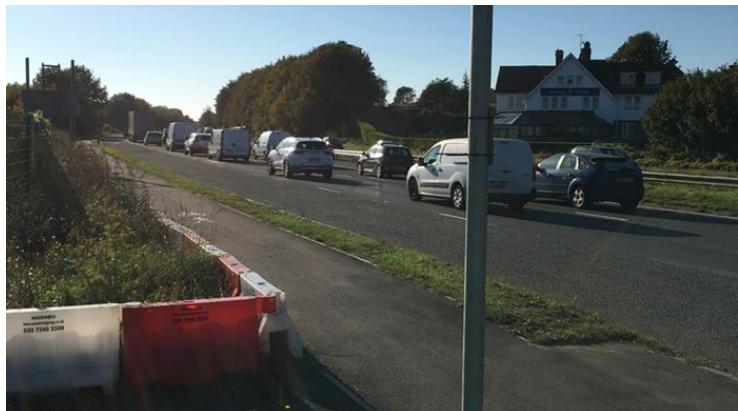
Figure 5 – Westbound exit blocking at Sussex Pad

again, but the site can also experience westbound exit blocking towards the A27/A2025 roundabout, **Figures 5 and 6** refers Eastbound queues are typically short in the evening peak.

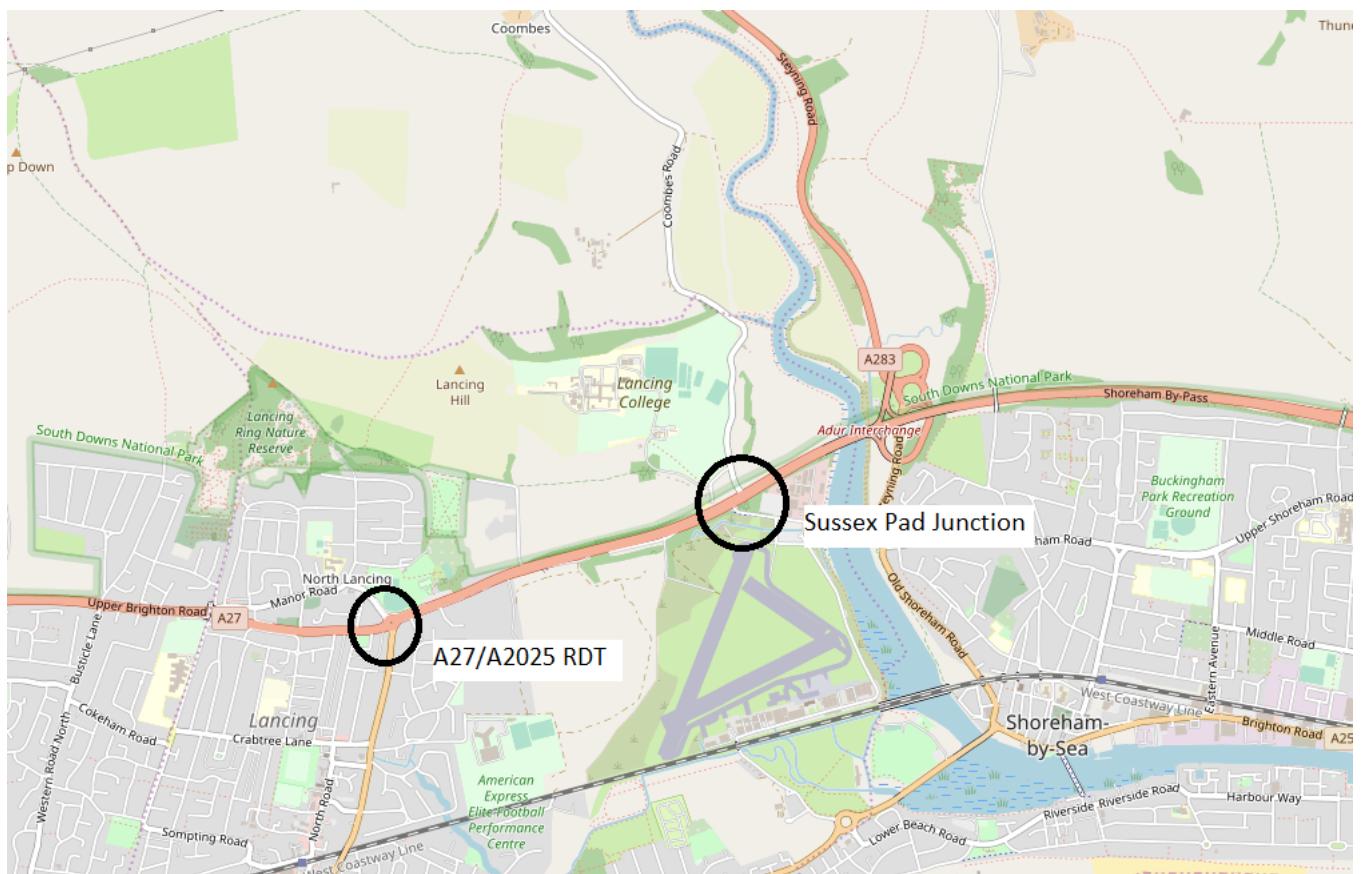
Figure 6 - Sussex Pad Location Plan (@OpenStreetMap Contributors)

At the busiest periods A27 demand flows appear to be able to approach a true, unrestricted saturation flow figure i.e. there could be in the region of 1800 vehicles per hour per lane demand on the busiest lanes and approaches. Eastbound queues extend well to the west of the A27/A2025 roundabout, **Figure 6**.

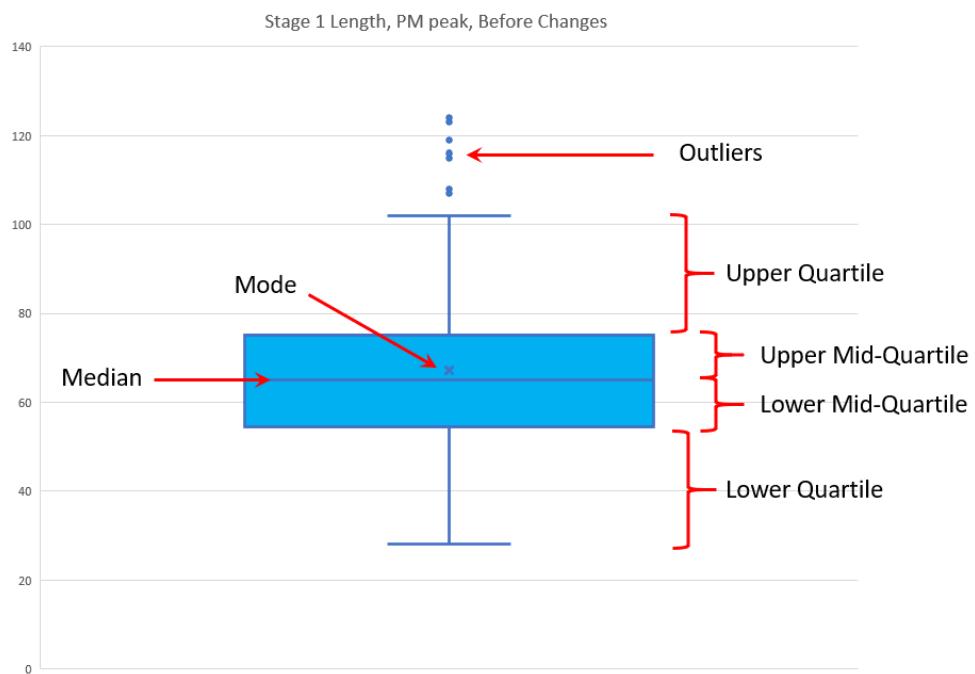
Figure 7 - Understanding box and whisper plots

Some simple statistical analysis was performed of the ‘before and after’ durations of stage 1, to gain further insight into the impact made on site. Stage 1 gives green to both east and westbound A27 ahead movements, the heaviest movements on the site. This analysis is expressed below in the ‘box and whisker’ plots. Box and whisker plots are explained in **Figure 7**.

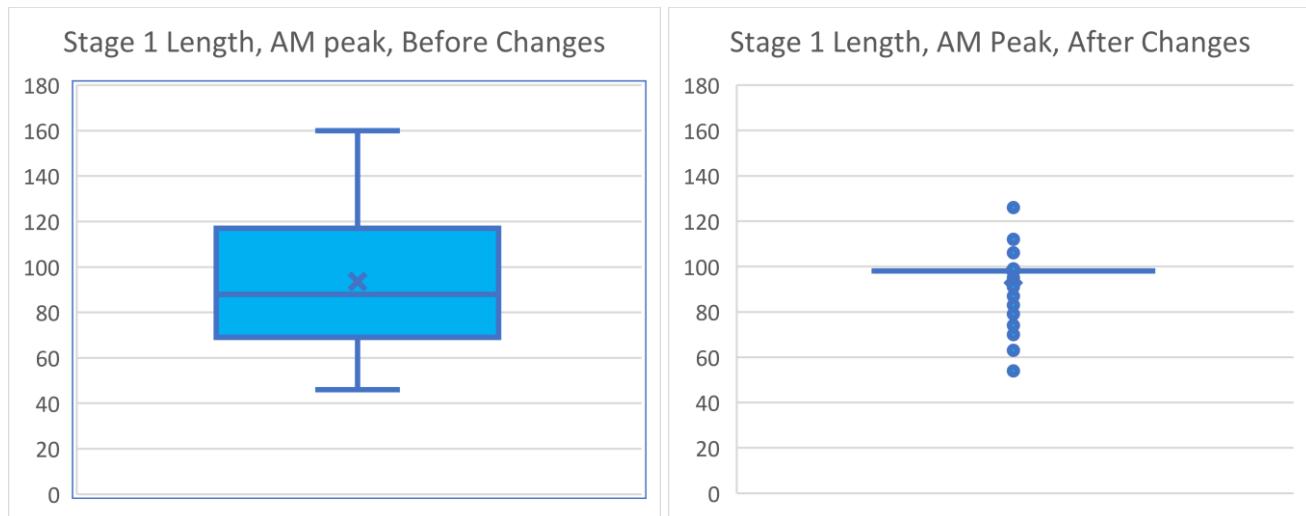
Figure 8 - Stage 1 durations, AM, before and after

Figure 8 shows the how stage 1 (A27 phases) operated pre validation activities and post validation. The plots demonstrate a greatly reduced inconsistency in stage duration in the morning peak. The median and mode have also both increased slightly. (The distribution of stage durations is so ‘tight’ it is not possible to see the quartiles in the ‘after changes’ situation). Therefore, in the morning peak the main A27 ahead movements have a slightly increased stage duration, which is significantly more consistent in duration.

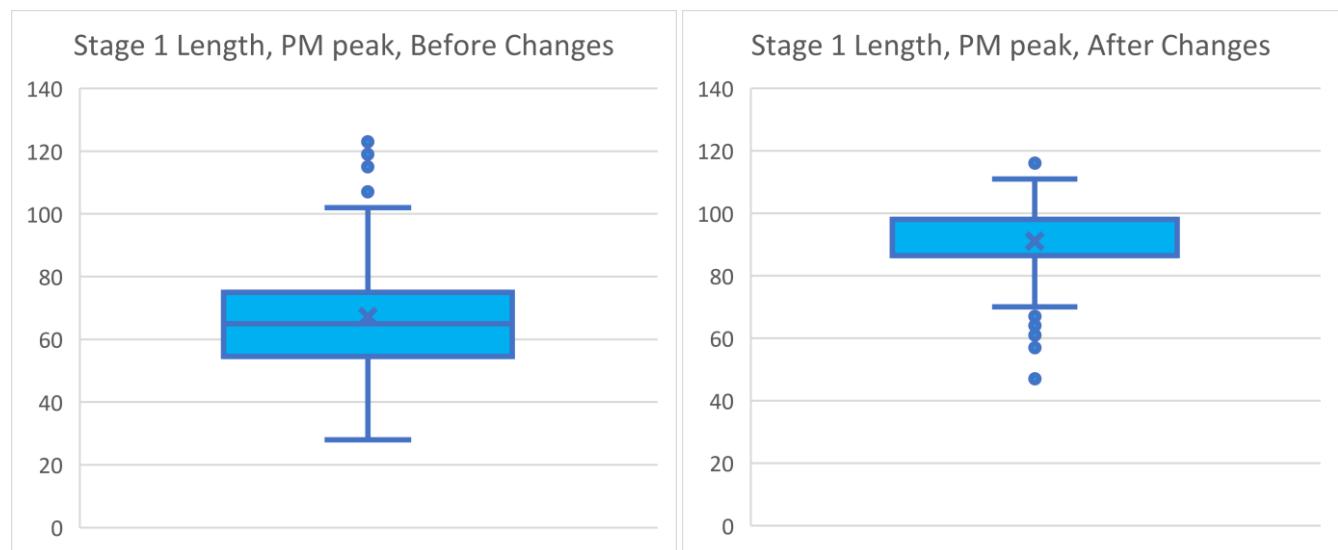
Figure 9 Stage 1 durations, PM, before and after

Figure 9 shows the PM peak pre and post validation. It shows that the distribution of the stage lengths has again greatly reduced in the ‘after’ situation, demonstrating reduced inconsistency in the evening peak. The median and mode stage duration have both increased significantly. Therefore, in the evening peak the main A27 ahead movements have a significantly increased stage duration, which is more consistent.

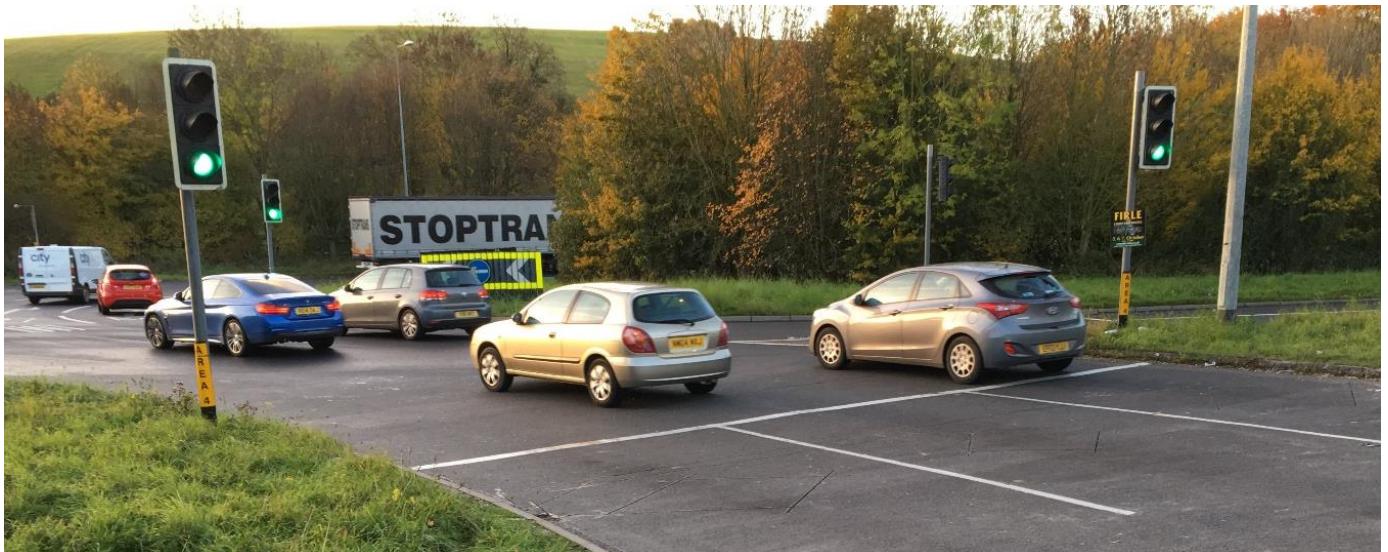
Figure 10 - A27 Ashcombe Roundabout

The A27 Ashcombe Roundabout site is a 4 arm roundabout to the west of Lewes, **Figure 10** refers. The A27 eastbound approach and Brighton Road approaches are signalised (along with the conflicting circulatory links). The other approaches are unsignalised. Whilst it has previously operated MOVA, upon arrival the site operated VA control and was monitored via UTC. The site has controlled pedestrian crossings over the A27 on the western side of the roundabout. The site was found to have detector faults, which meant that the site performance was unreactive, and the green times were too long. In the all periods the VA operation in use was considered poor. The detector faults present were causing long green times and the site performance was very unreactive. Some detector performance was found to be intermittent and not necessarily reporting as faults in the controller or MOVA logs, although their performance was incorrect.

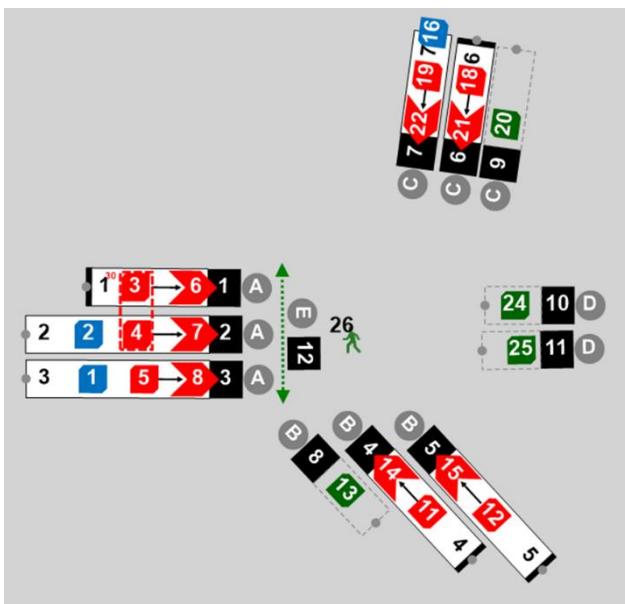
Figure 11 - A27 Ashcombe MOVA Diagram

MOVA was able to successfully operate with the relatively high number of detector faults at the site. MOVA correctly worked from each links 'alternate up' or 'alternate down' detectors to determine green times. The site performance was more heavily constrained by the physical position of the detectors than the level of faulty detectors. This is especially true for the X detectors on the A27 which are closer than ideal to the stop line. However, it was possible to configure MOVA to work well with the infrastructure present.

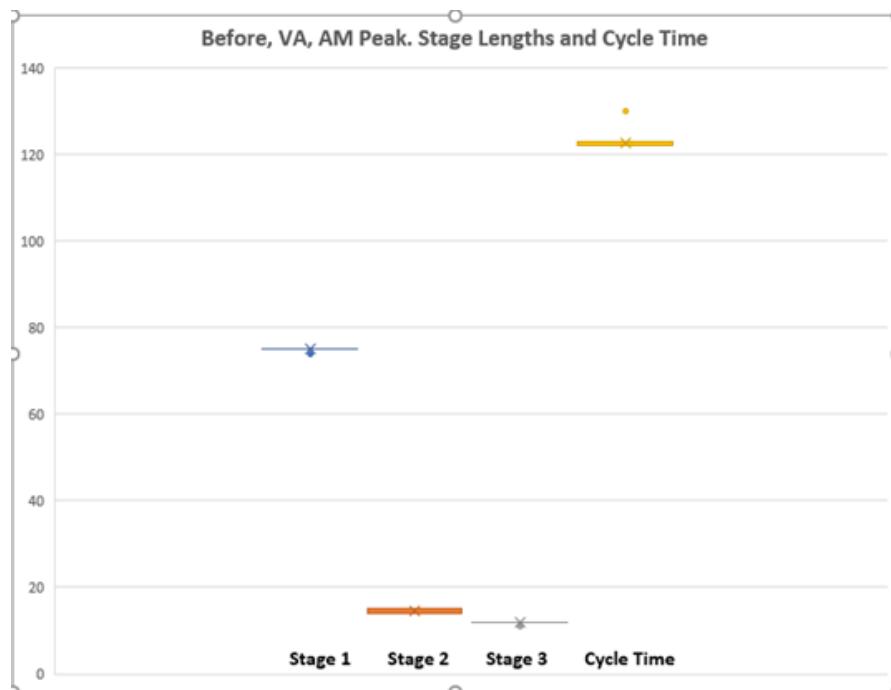
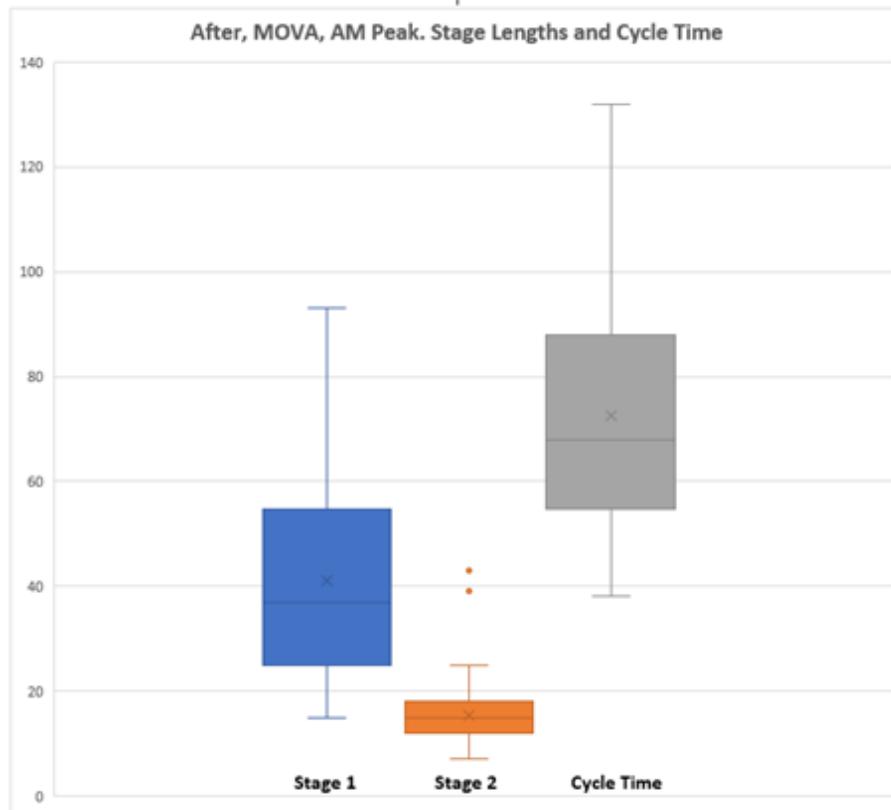
Figures 11 and 12 above show the before and after timings for the morning peak. In the before situation, with VA control, fixed stage durations for stages 1, 2 and 3 can be seen, giving a virtually fixed cycle time of 122s. In the after situation, with MOVA control, queue clearance stage 3 was found unnecessary and does not operate. Stages 1 and 2 show much more variation, typically running much shorter green times than VA, but also having maximum durations

above VA. The median cycle time is 68s, almost half than on VA, but again shows the ability to operate significantly shorter and longer than this, depending on traffic conditions.

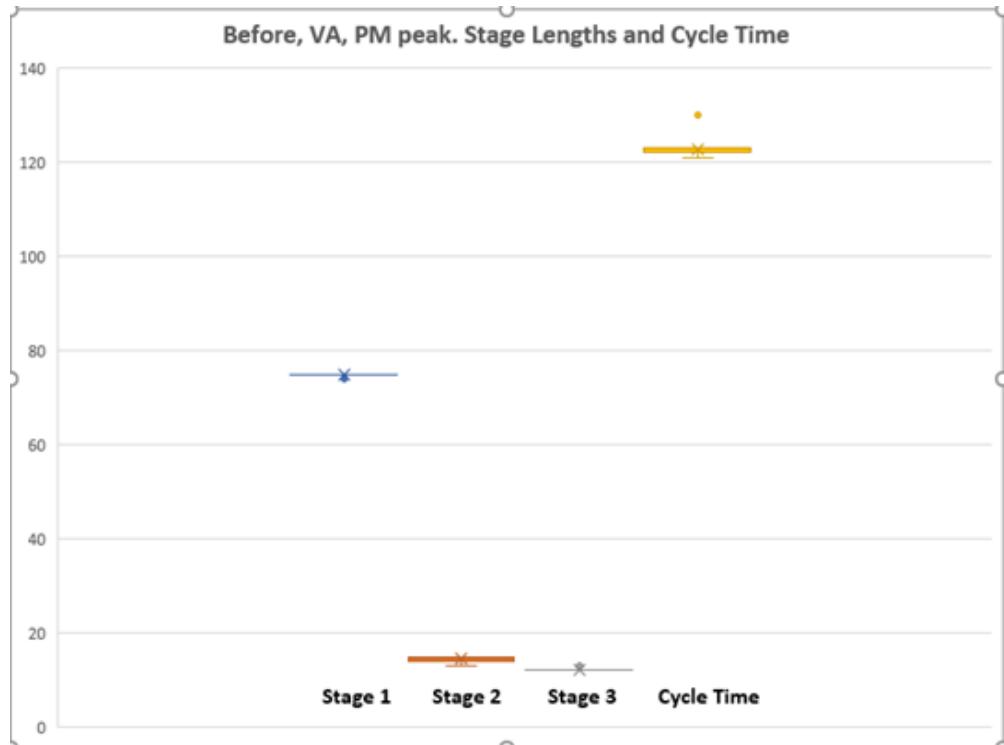
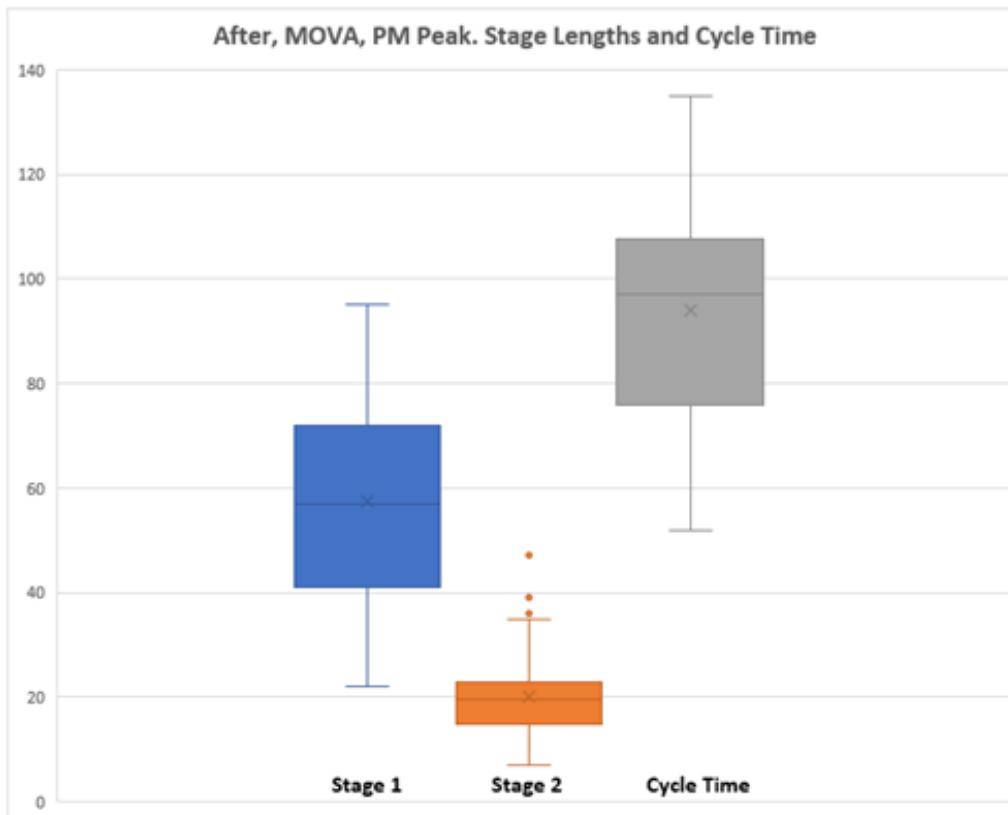
Figures 13 and 14 show before and after timings for the evening peak and show performance very much like the morning peak: VA control operates virtually as fixed time control, with a fixed 122s cycle time. MOVA shows significantly more variation again, with a median cycle time of 97s and stage durations typically shorter, but with much greater variation, in response to changes in traffic conditions. Again, queue clearance stage 3 was found unnecessary under MOVA control.
