Innovations in bridge mounted detection: Overcoming challenges in South Wales

The South Wales Trunk Road Agent (SWTRA), working with Atkins, had a requirement to design and install traffic signal upgrades on the A48 in Port Talbot. Two of the sites involved were adjacent to the A48 Briton Ferry Bridge. See Figure 1 below for the general site layout.

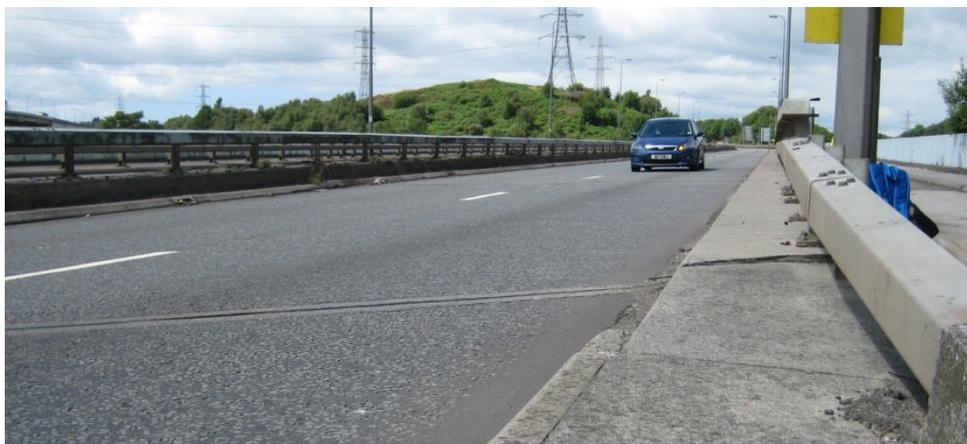
Figure 3 Bridge Eastbound Approach

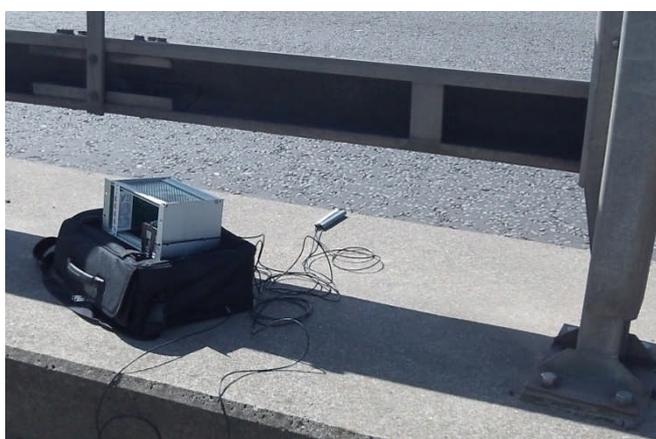
Figure 6 - Radix Magnetometer Trial Equipment

For the trial, Radix were able to bring a battery powered magnetometer and detector card to replicate the operation of an installed detector. A number of different installation positions and orientations were trialled with varying degrees of success.

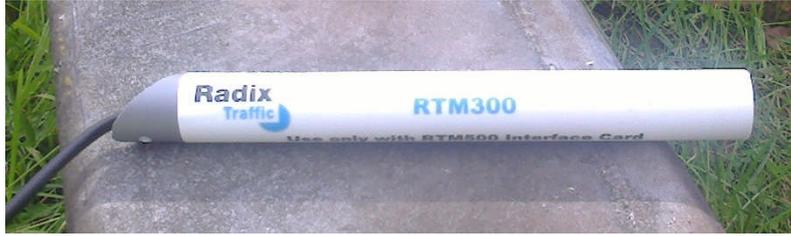
Figure 8 Radix Magnetometer Detector

Figures 8, 9 and 10 above show some of the installation. The main constituents of the design comprised of:

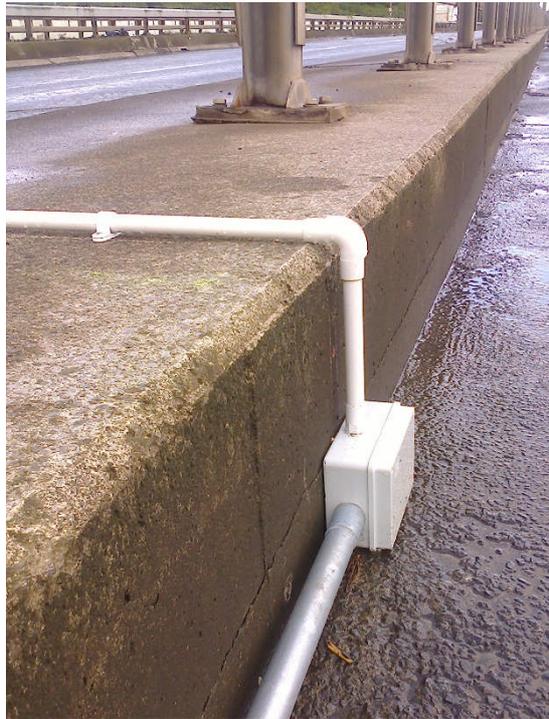
Figure 9 Conduit and IP Rated Joint Box

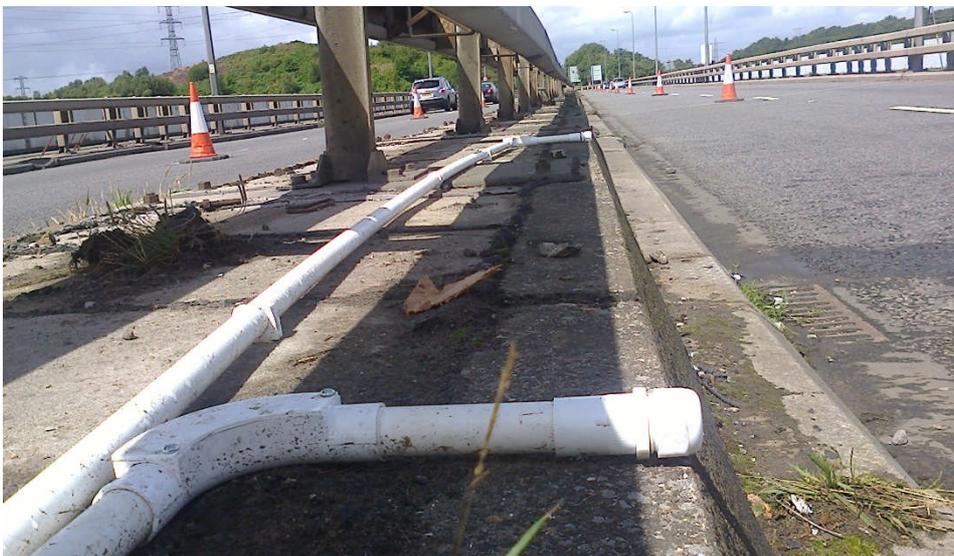
Figure 10 Uni-Directional Detection Position
